# **CLARKSTON CITY HALL ANNEX RENOVATION OF MORRIS FAMILY HOUSE**

**CITY MANAGERS PROGRESS REPORT #1**

**November 5<sup>th</sup> to November 21<sup>st</sup>, 2012**

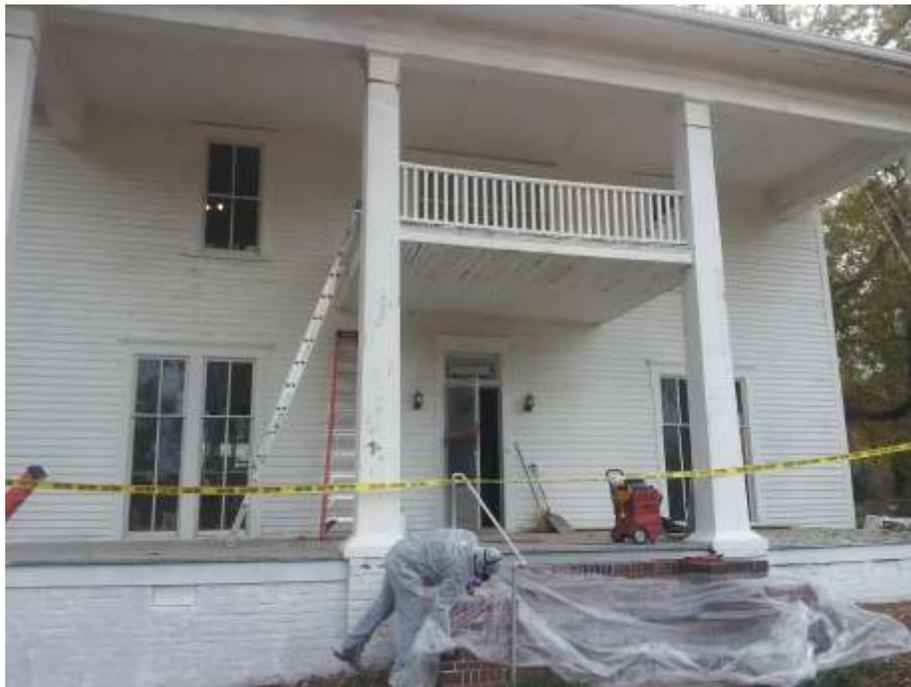
**November 14<sup>th</sup>, 2012**

**Encapsulation of lead paint on exterior of house using “Eco Bond”. Eco Bond is a lead treatment product that seals lead paint and lead dust in-place which results in a non-hazardous environment.**

**Eco Bond is a phosphate based reagent that that adheres to lead based surfaces. Eco Bond also penetrates several layers of paint to the original wood surface.**

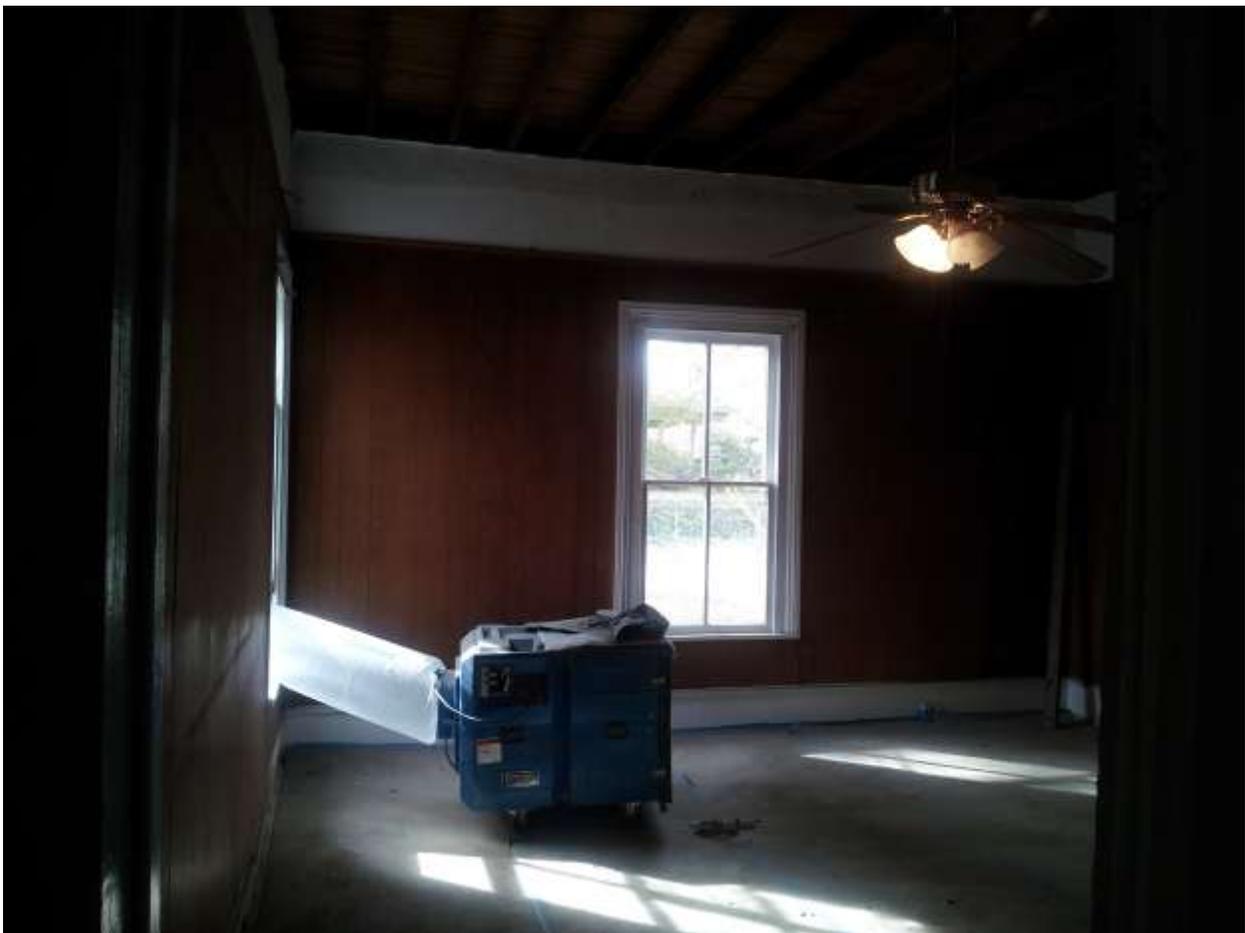
November 14, 2012

**Negative air pressure provided during interior demolition activities**

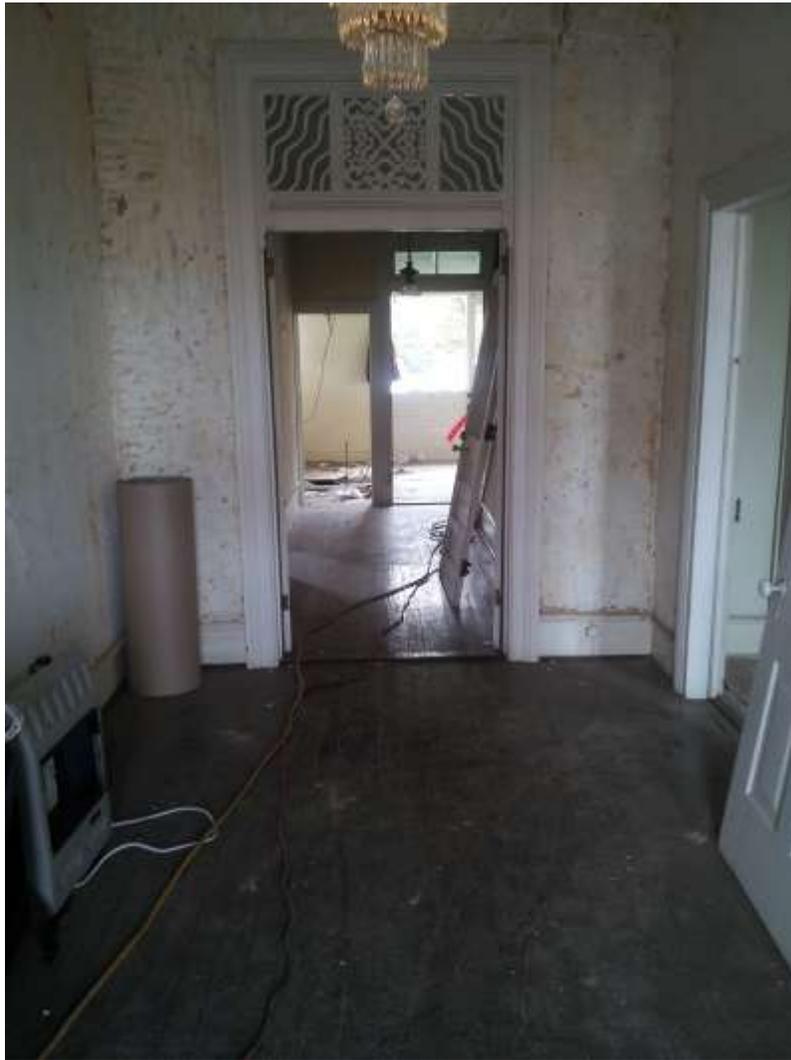
November 14<sup>th</sup>, 2012

**Wallpaper removed from walls downstairs hallway**

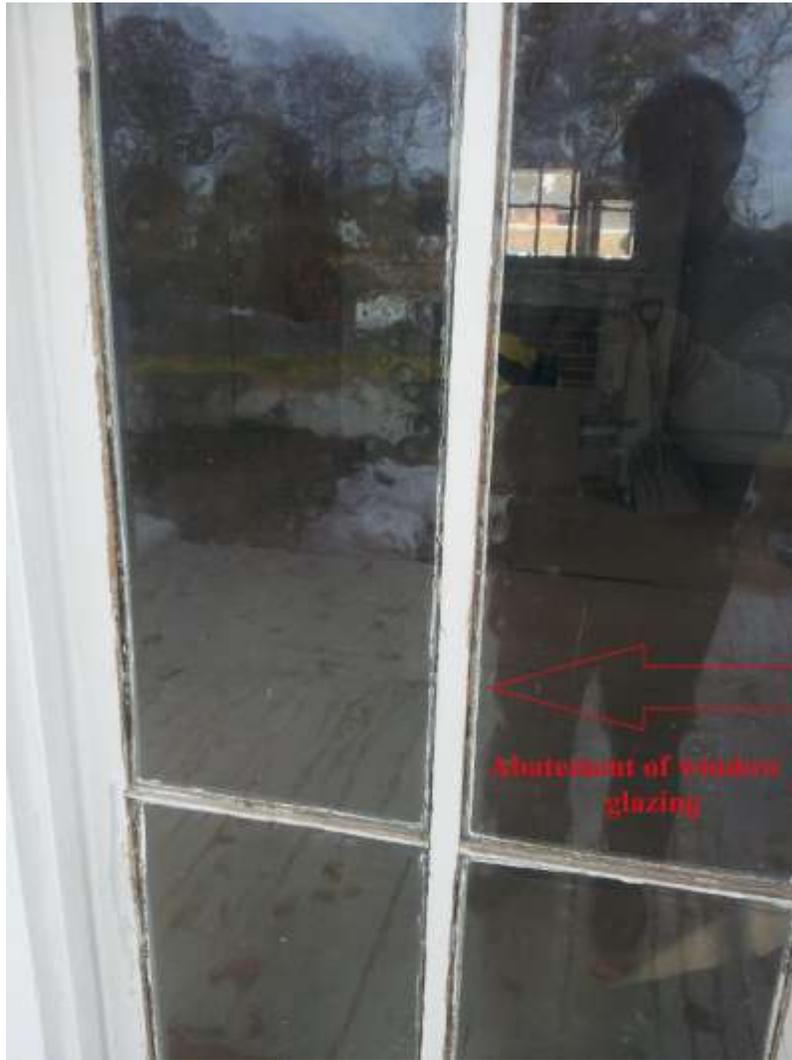
November 14<sup>th</sup>, 2012

**Remediation (abatement) of window glazing on all windows – asbestos identified in the glazing material during plan preparation**

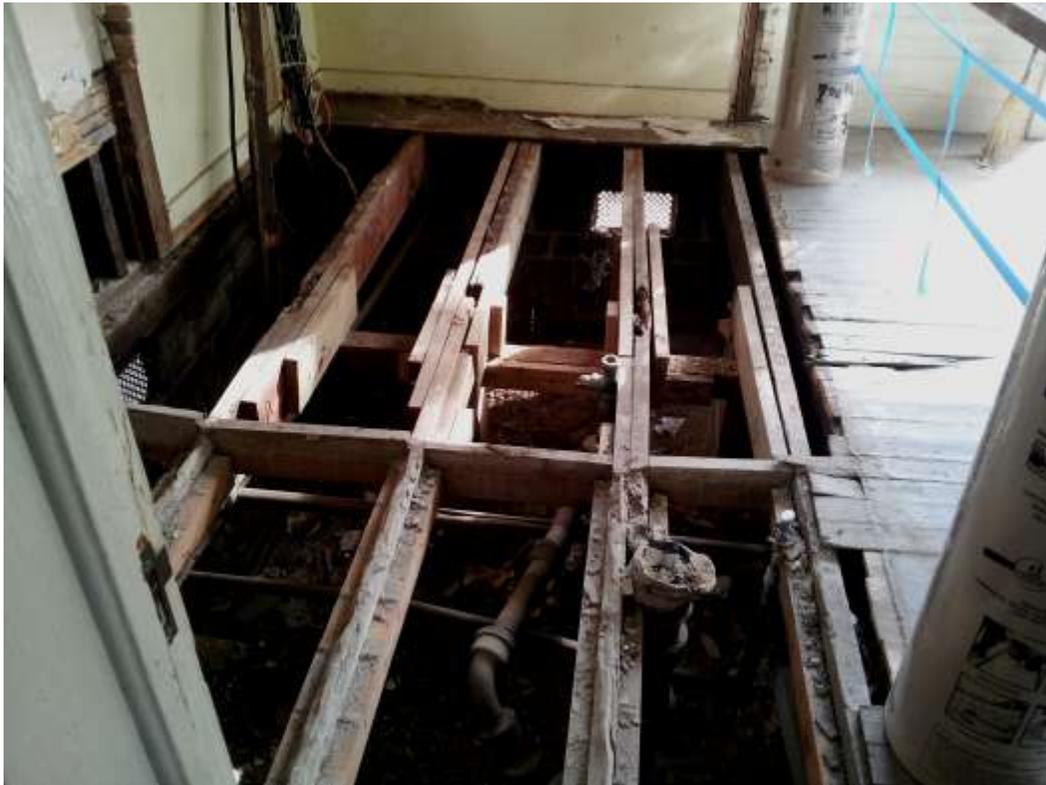
November 20<sup>th</sup>, 2012

- ✓ Plans call for patching plaster walls (25% of the wall area). Currently assessing alternatives; (a) removing all the plaster and lathe throughout the house and placement of new sheetrock, (b) placement of new sheetrock over the existing plaster walls throughout the house
- ✓ Back porch wood flooring, sub flooring and underlying joists damaged over 30% of floor

Wood flooring and joists deteriorated – back porch (utility room)

area. Remaining wood floor uneven. Entire back porch floor covered with artificial floor covering (astro turf material). Project team currently assessing; (a) whether to replace damaged joists and entire existing wood floor with a new plywood sub base and new wood flooring or (b) replace only water damaged floor areas and use existing floor as a sub base for new wood flooring

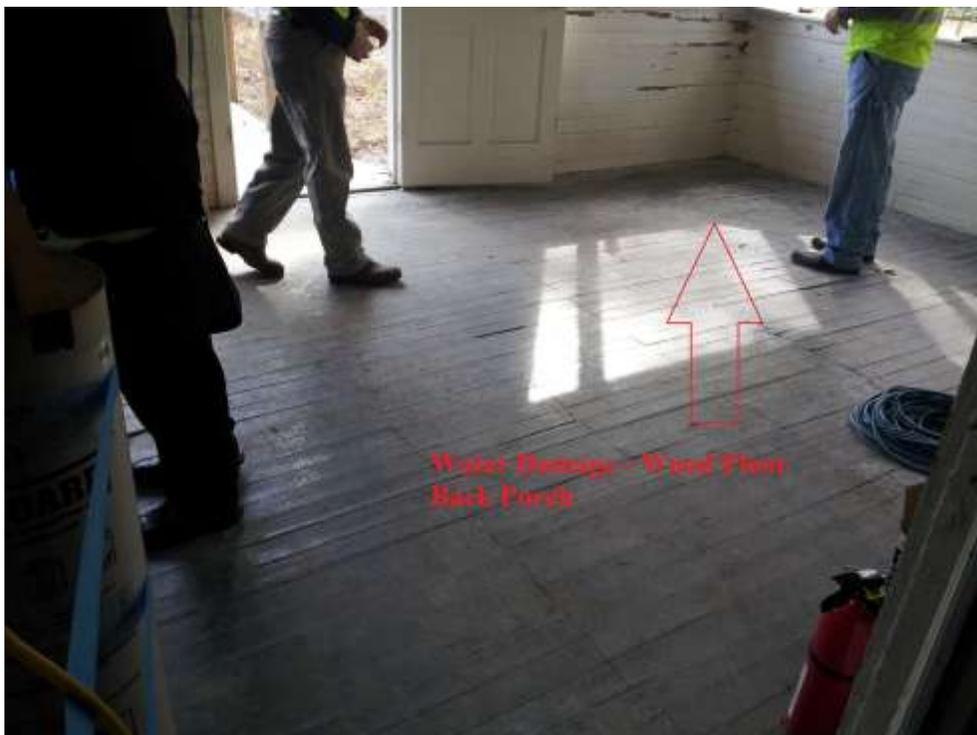
November 20<sup>th</sup>, 2012

Water damage back porch – southeast corner

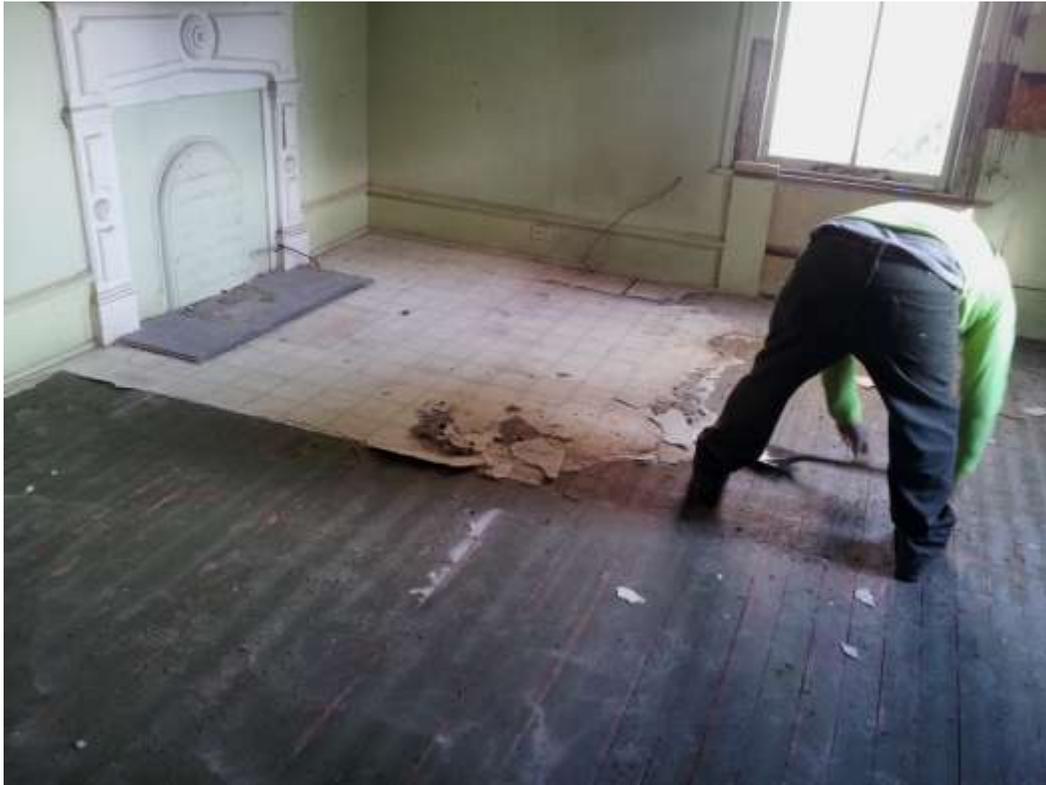
**November 20<sup>th</sup>, 2012**

**Removing vinyl flooring in former kitchen – see existing wood floor**

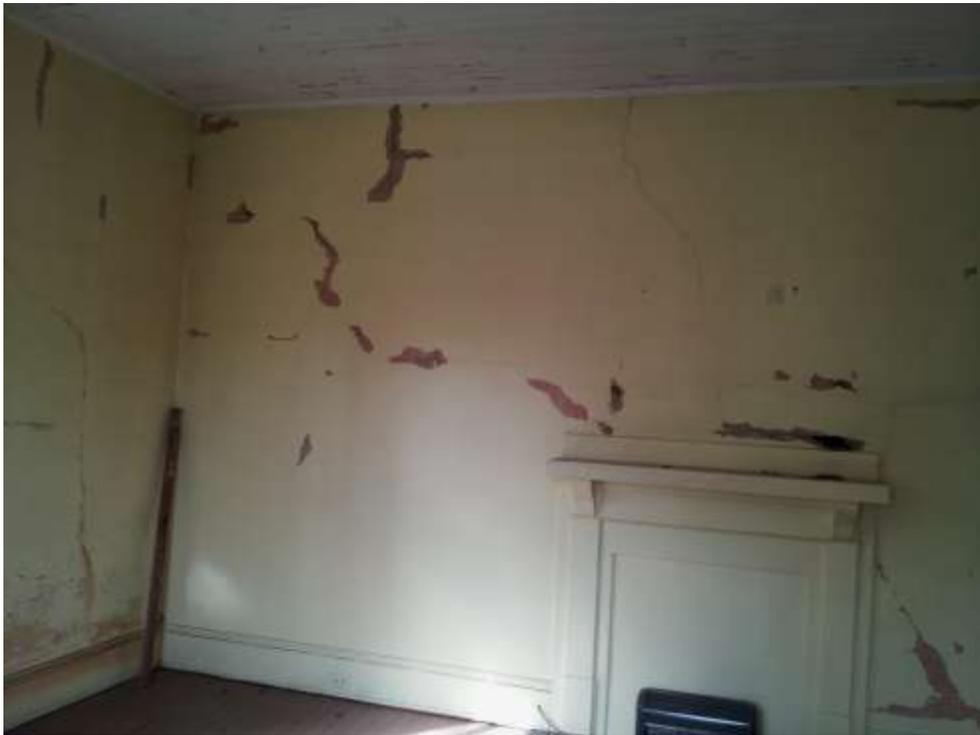
**November 20<sup>th</sup>, 2012**

**Cracking on plaster walls – typical**

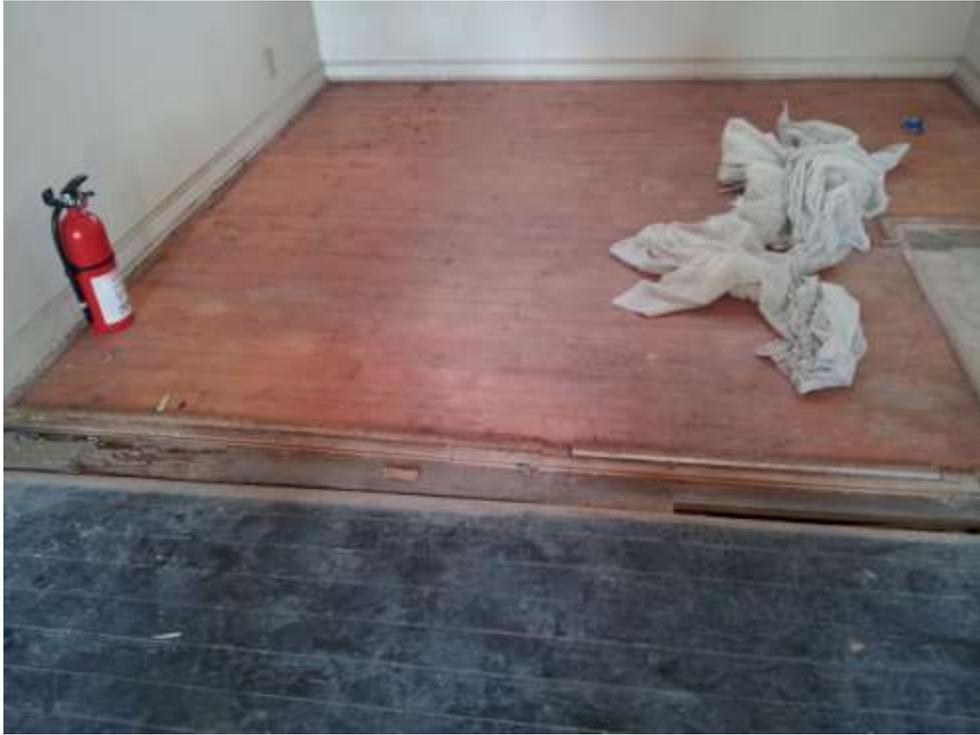
**November 20<sup>th</sup>, 2012**

**Several layers of flooring in future sitting room (top of pic. – reddish brown color)  
Hallway existing flooring (bottom of pic. - dark brown color)  
Elevation difference of floor areas to be resolved**

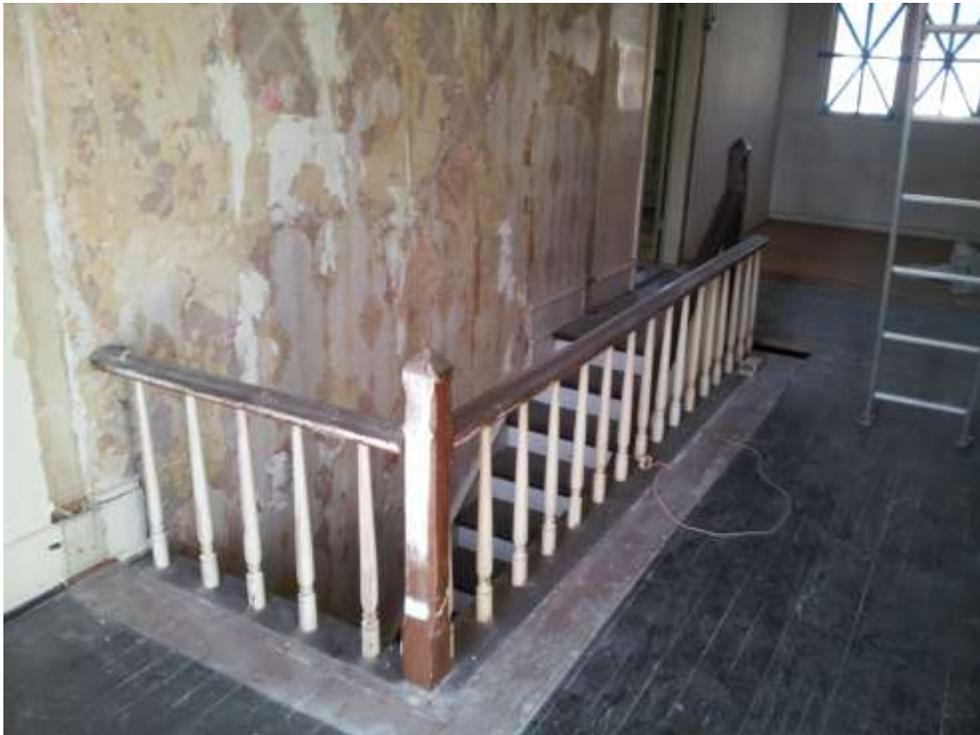
**November 20<sup>th</sup>, 2012**

**Wall at top of staircase removed for fire safety code  
Protective poles/barrier to be installed on outside of staircase railing**

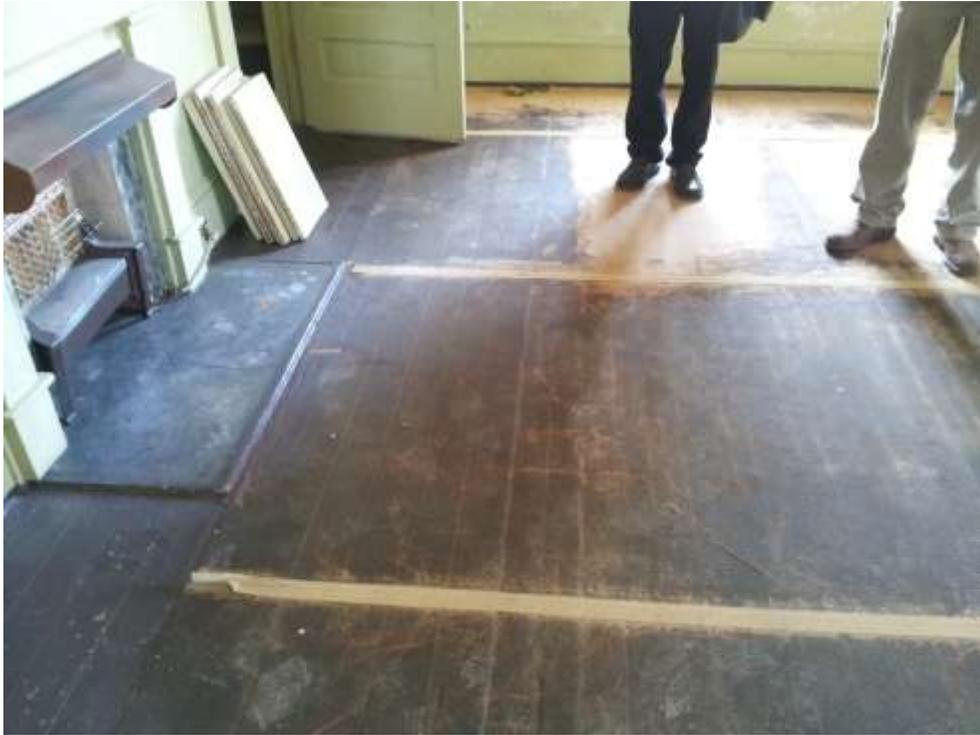
**November 20<sup>th</sup>, 2012**

**Carpet underlayment/pad glue adhered to wood floor – to be removed**

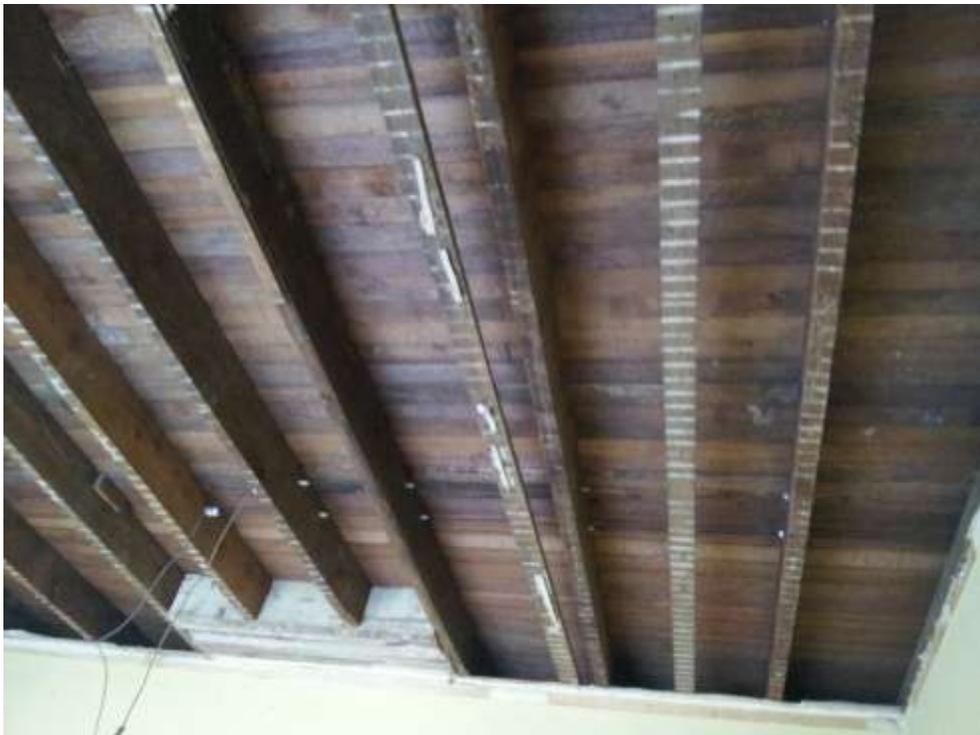
**November 20<sup>th</sup>, 2012**

**Floor joist width, depth and orientation variable throughout house – structural enhancements to flooring system per plans – additional joists to be added**
