CLARKSTON CITY HALL ANNEX RENOVATION OF MORRIS FAMILY HOUSE

CITY MANAGERS PROGRESS REPORT #2

November 22nd to December 17th

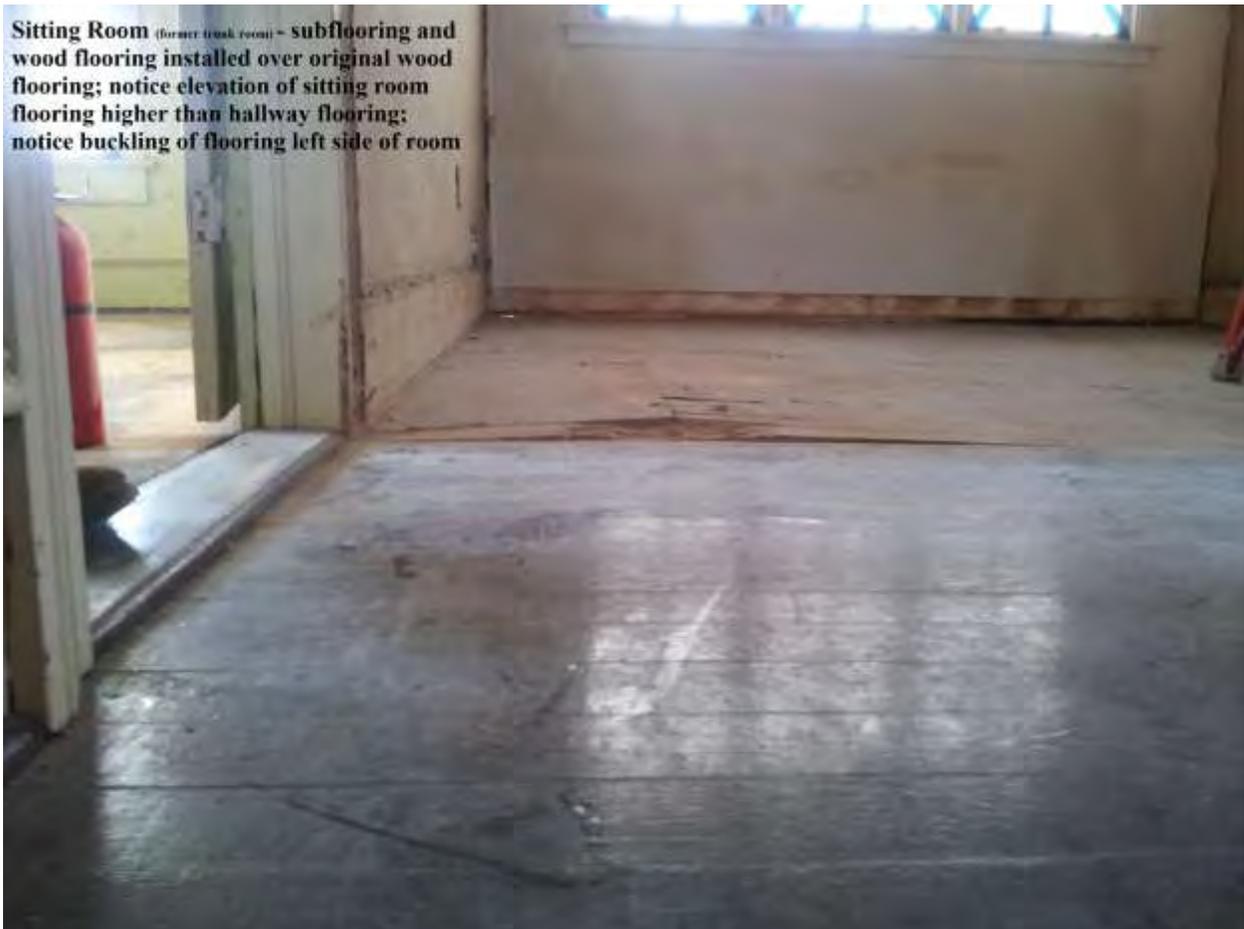
Sitting Room (former trash room) - subflooring and wood flooring installed over original wood flooring; notice elevation of sitting room flooring higher than hallway flooring; notice buckling of flooring left side of room

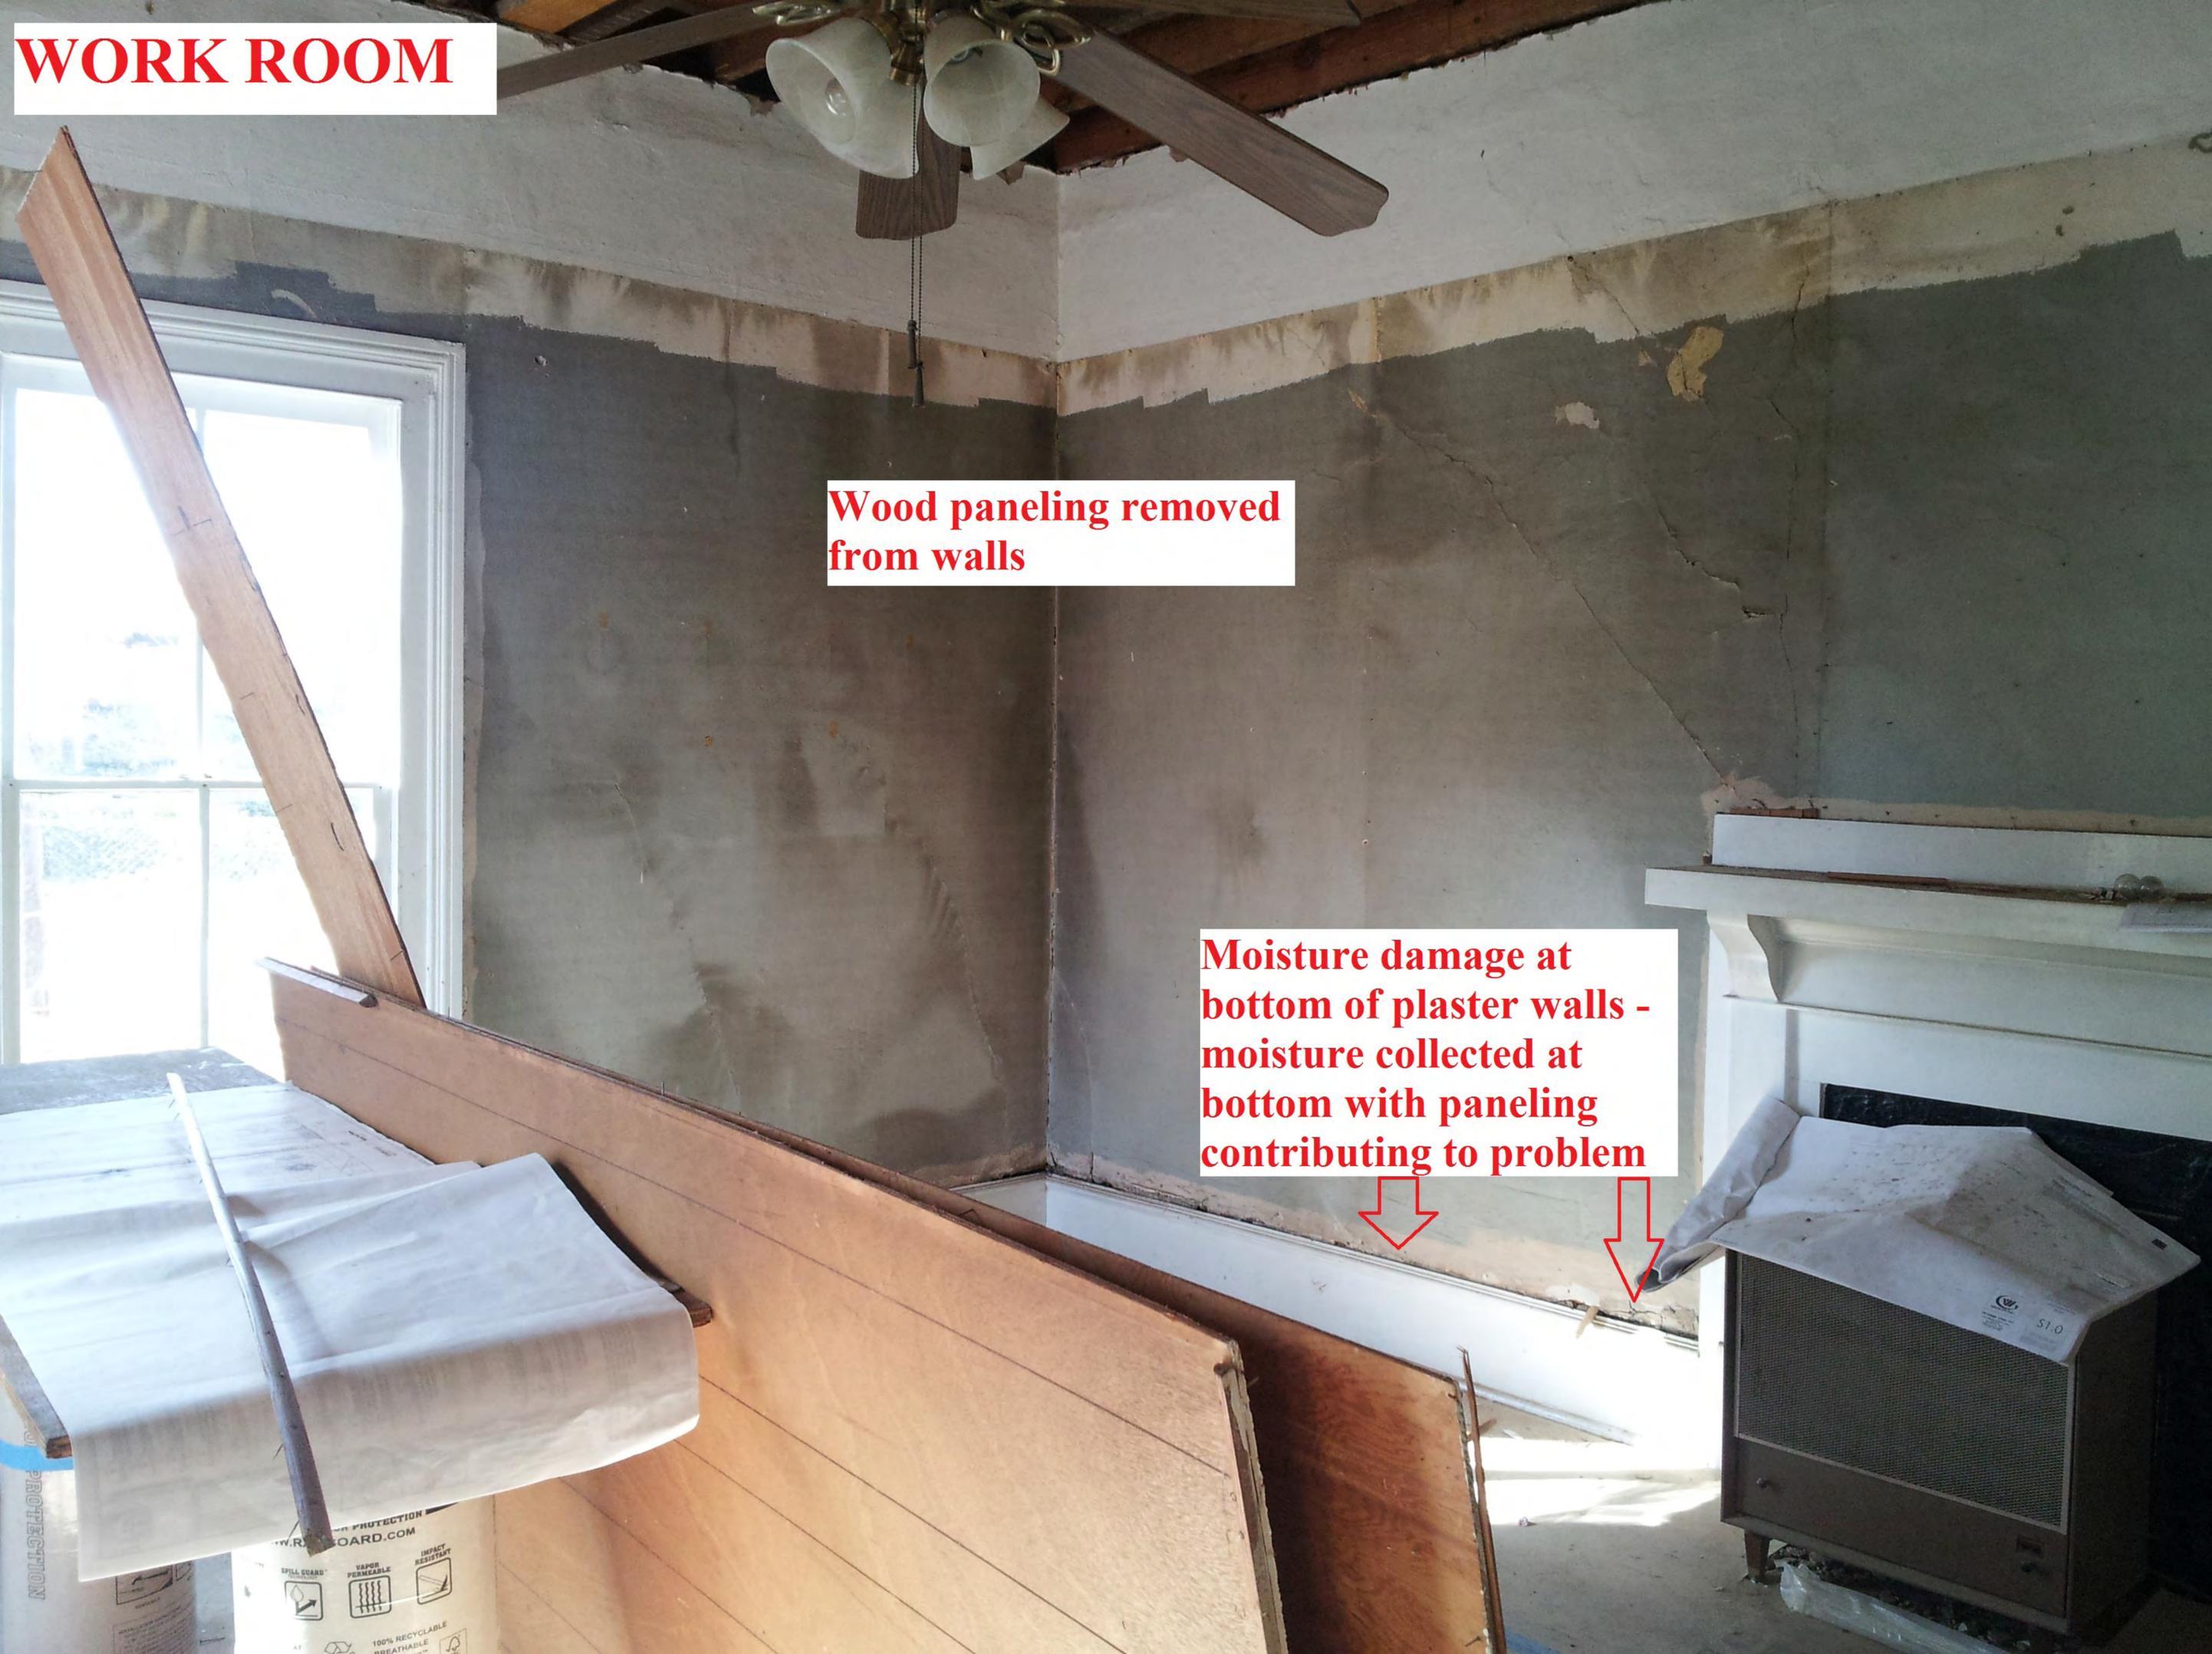
WORK ROOM

Wood paneling removed from walls

Moisture damage at bottom of plaster walls - moisture collected at bottom with paneling contributing to problem

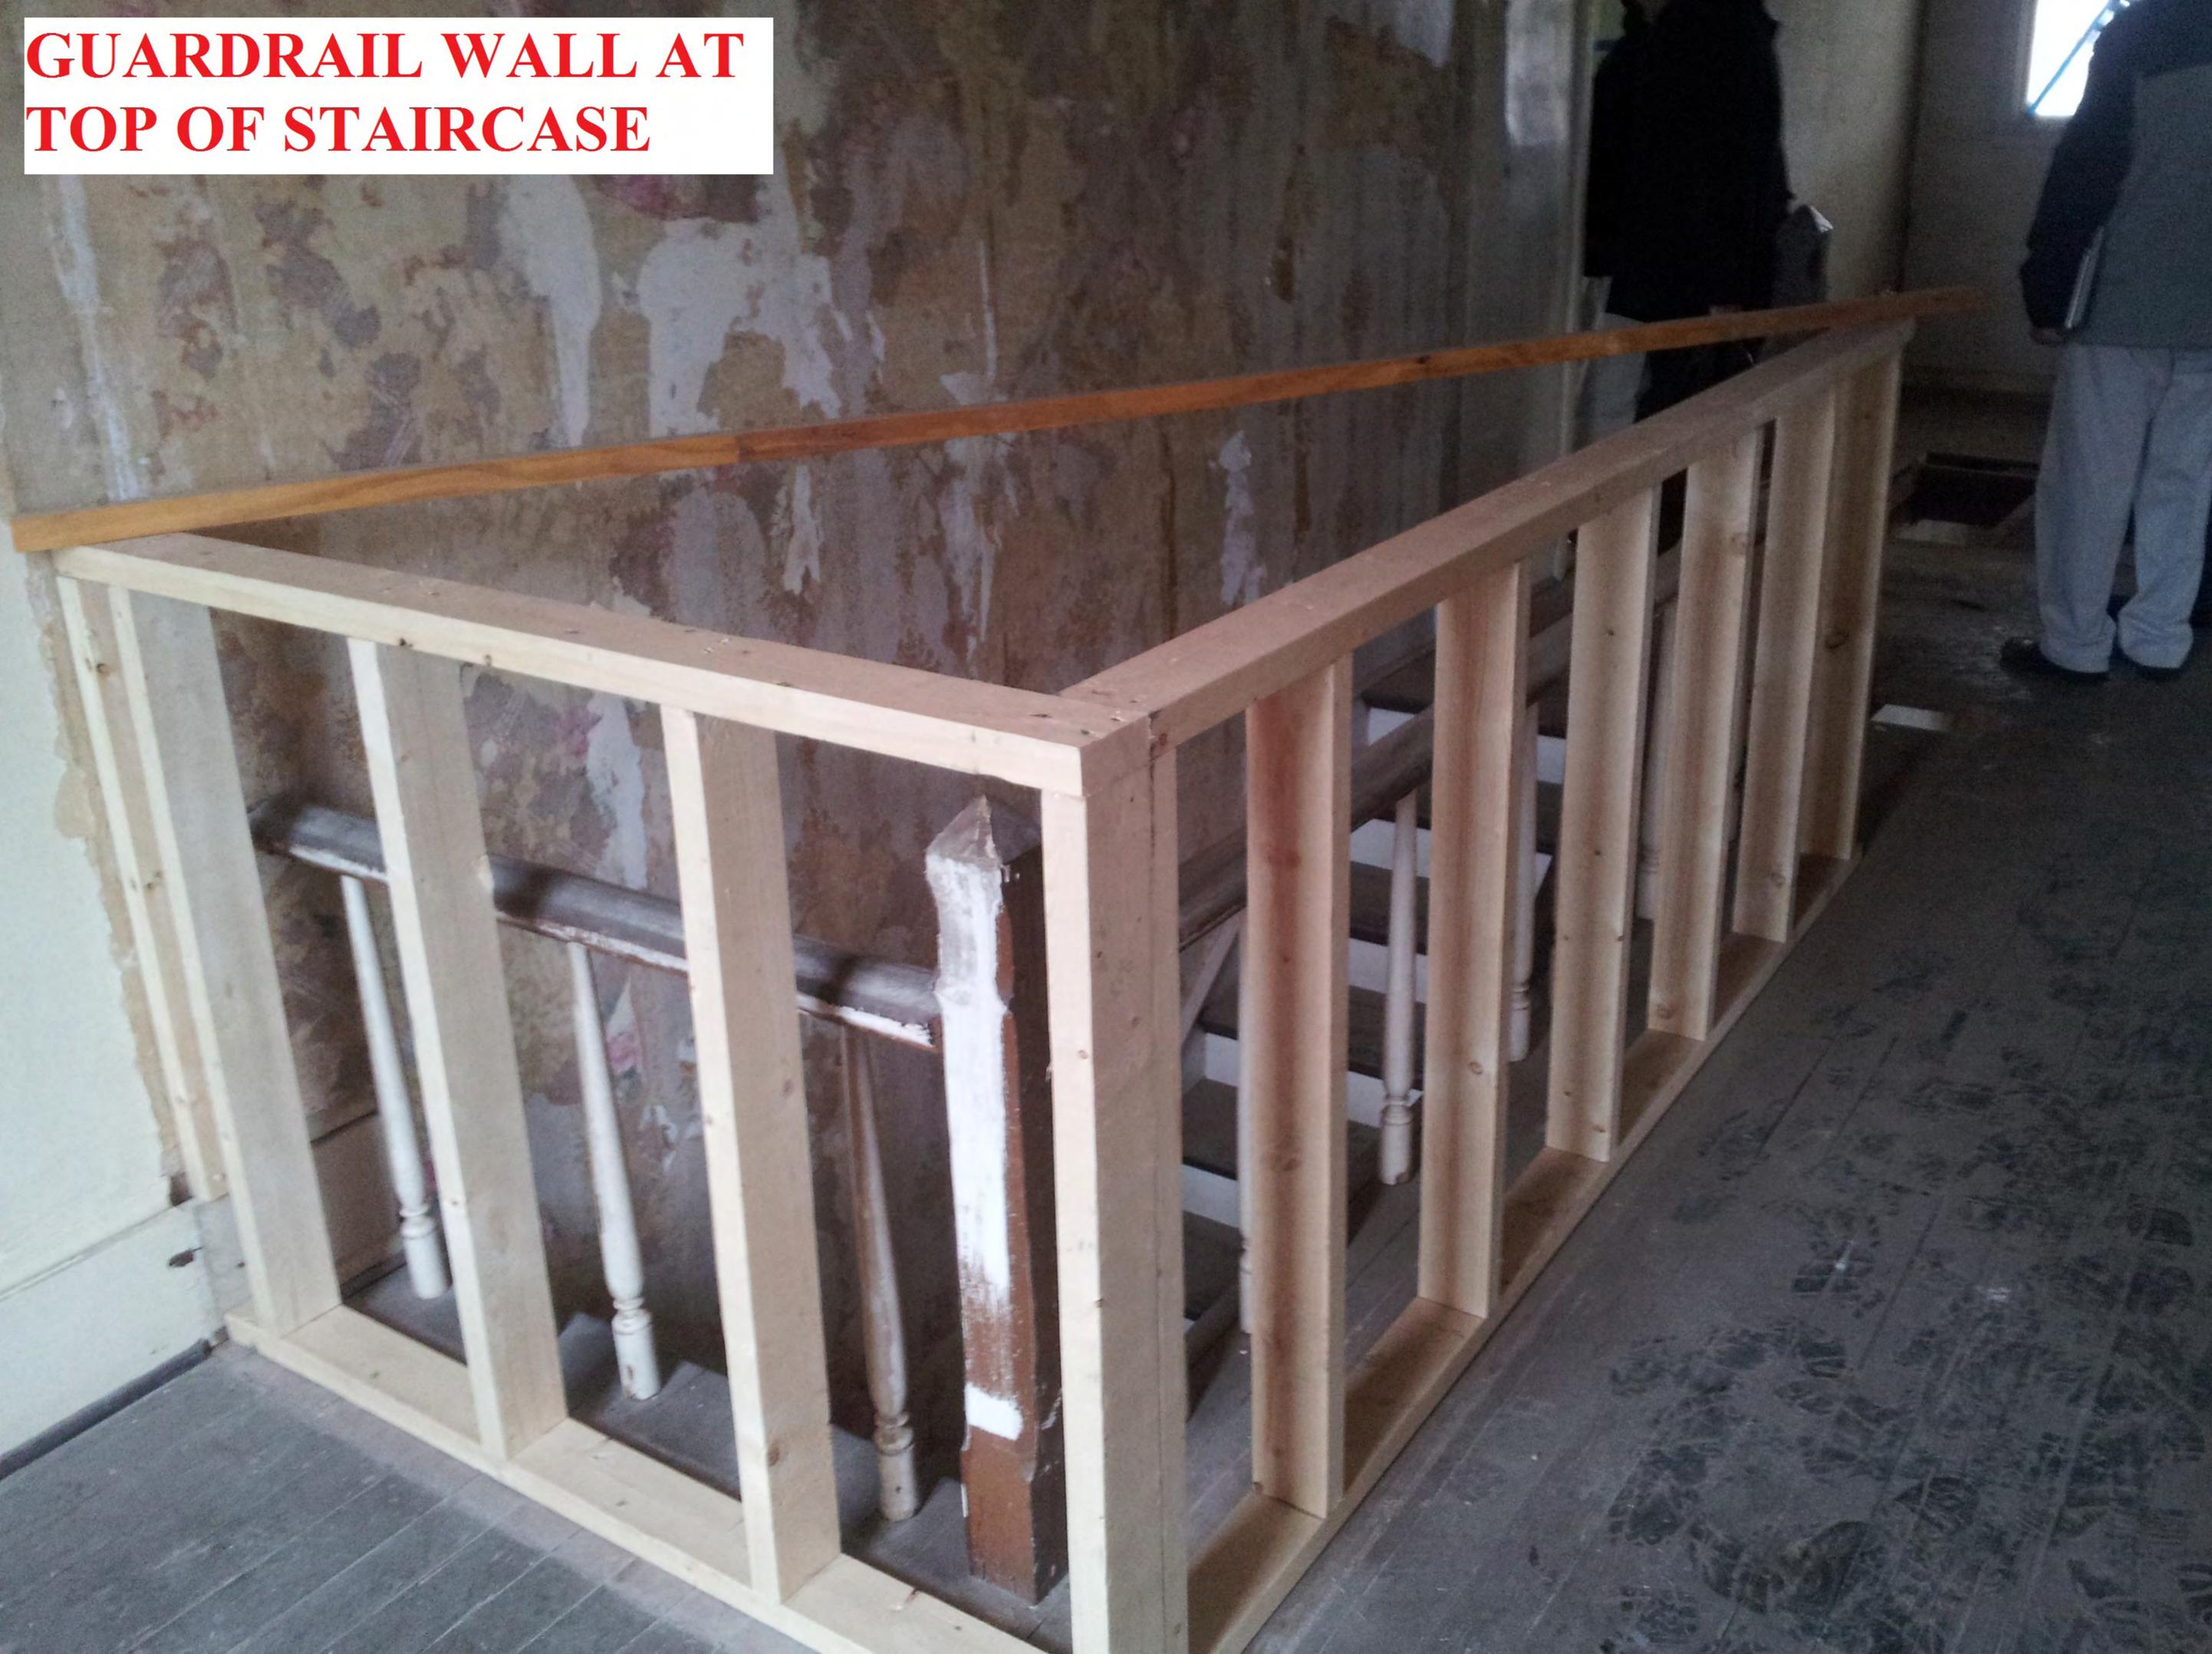
**GUARDRAIL WALL AT
TOP OF STAIRCASE**

- Guardrail wall framing at top of staircase partially complete
- Met with termite inspection vendor to discuss quote for services

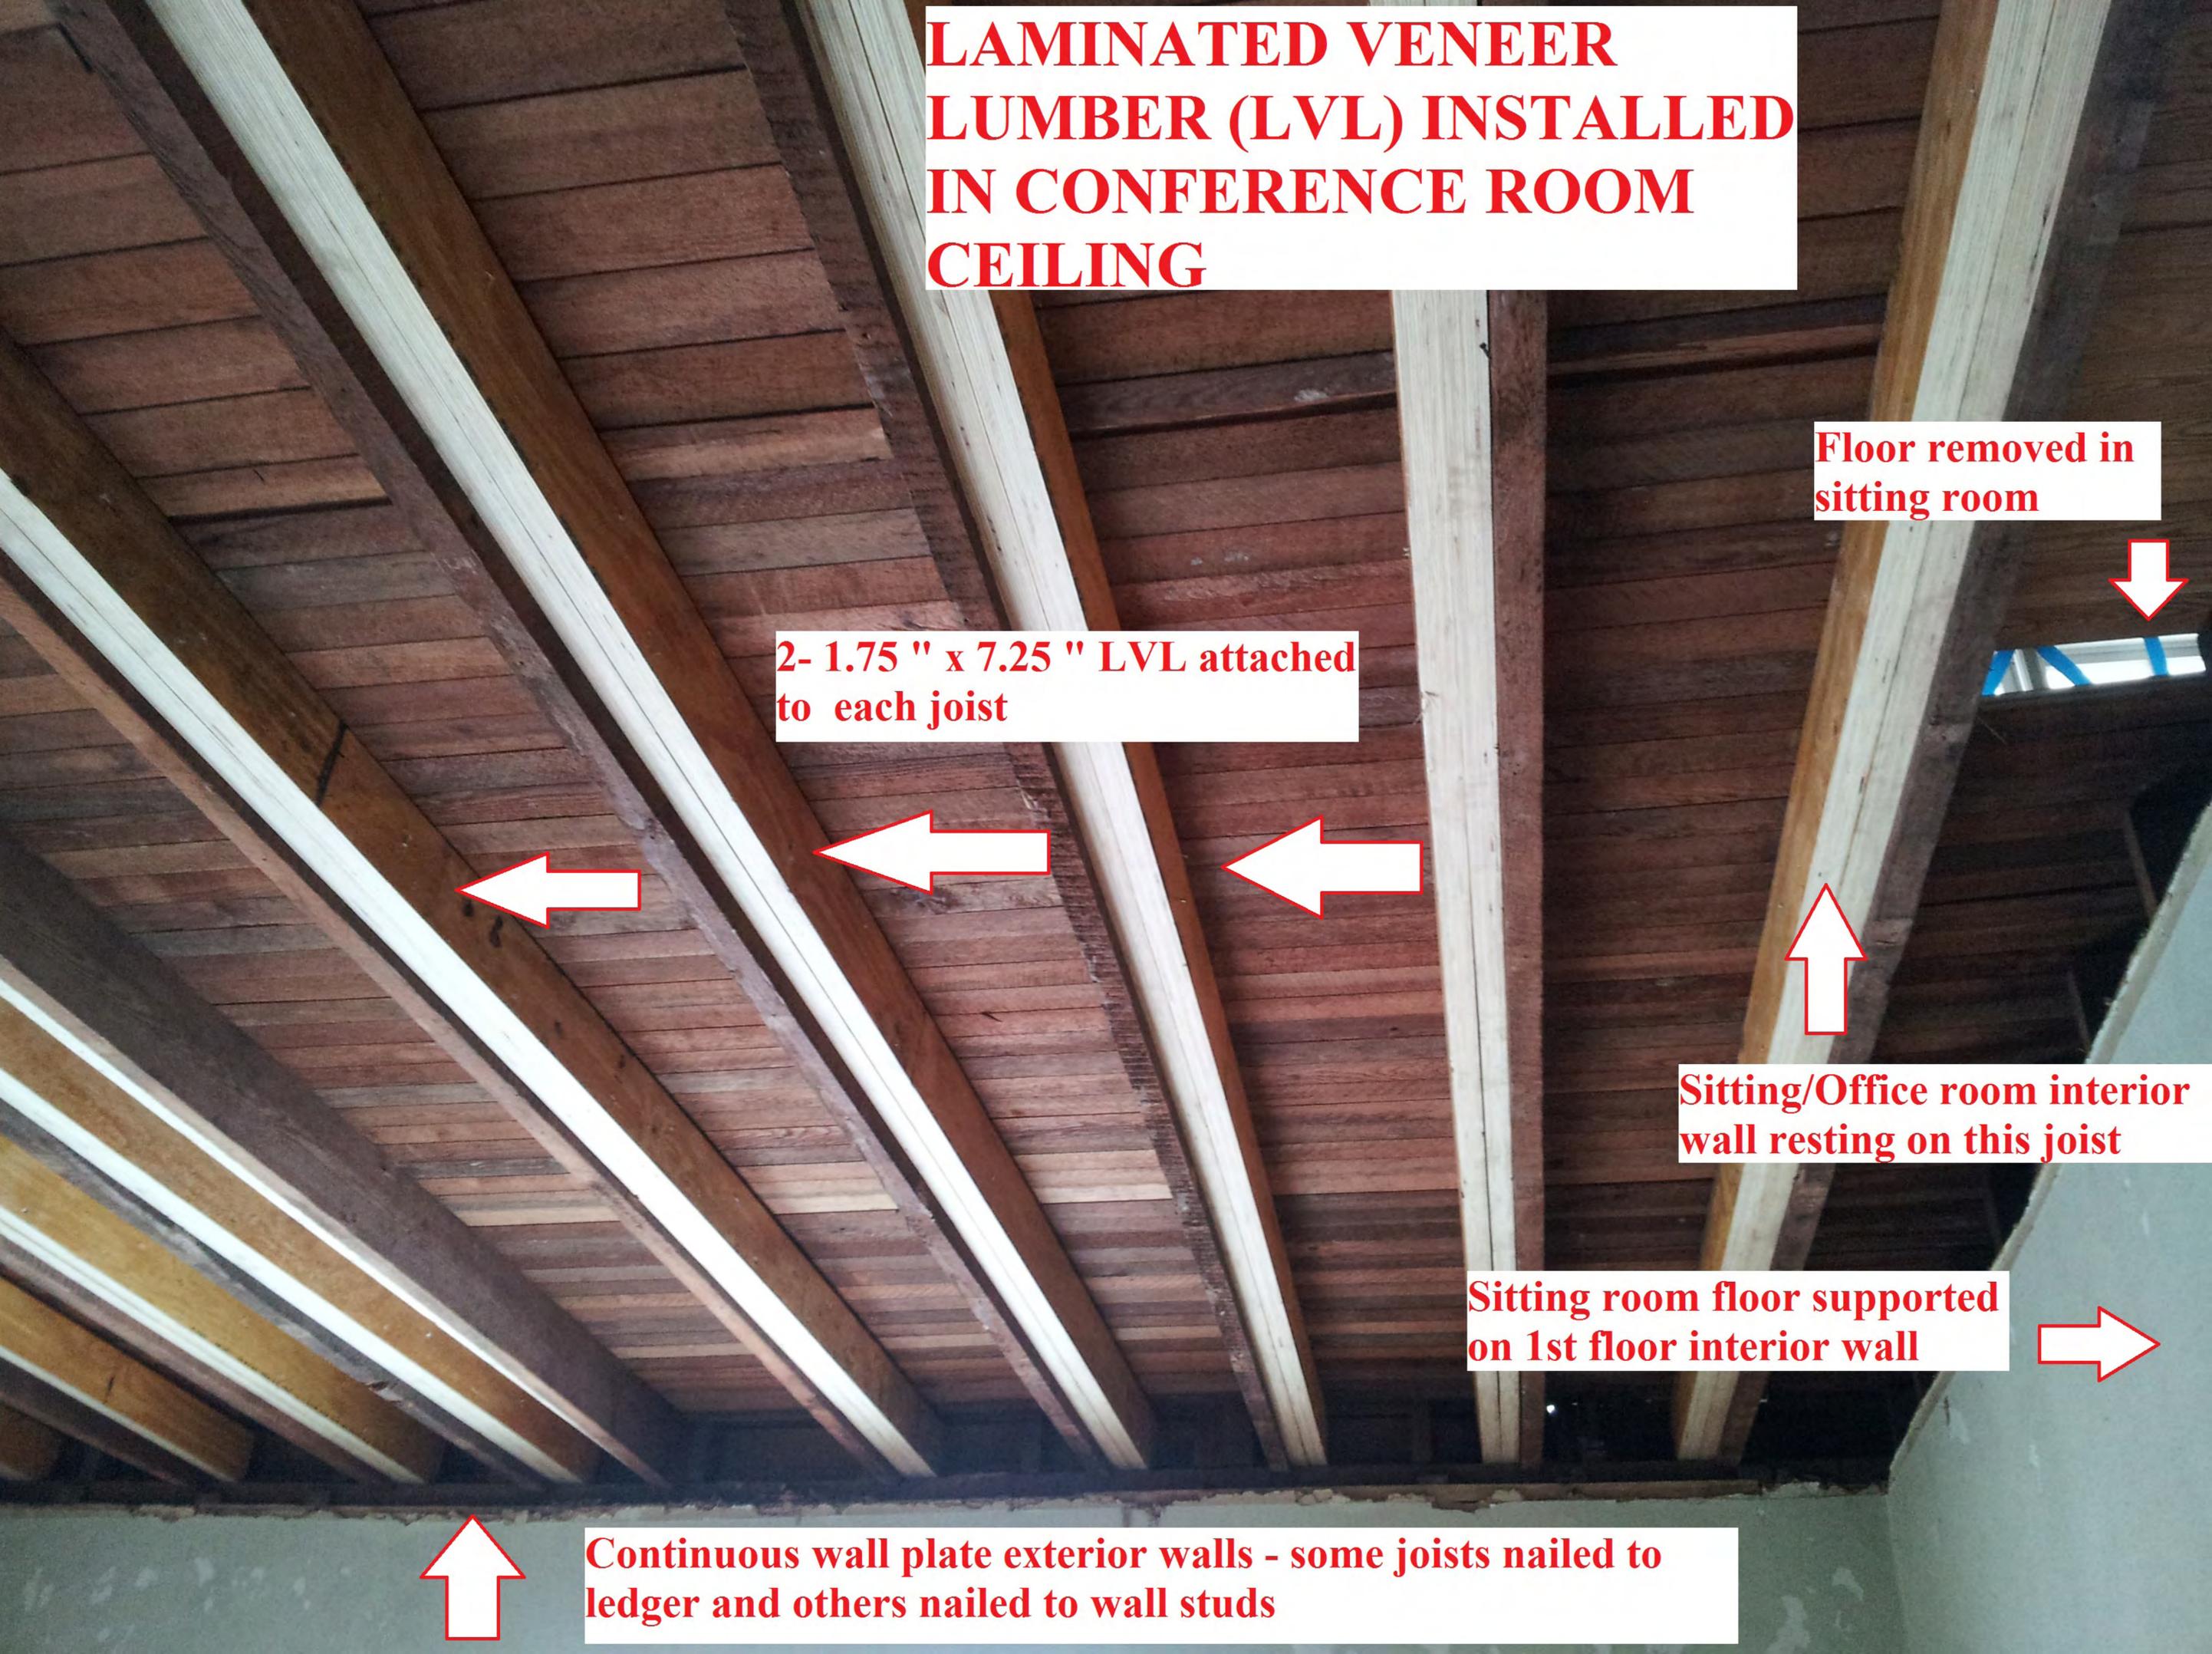
**LAMINATED VENEER
LUMBER (LVL) INSTALLED
IN CONFERENCE ROOM
CEILING**

**Floor removed in
sitting room**

**2- 1.75 " x 7.25 " LVL attached
to each joist**

**Sitting/Office room interior
wall resting on this joist**

**Sitting room floor supported
on 1st floor interior wall**

**Continuous wall plate exterior walls - some joists nailed to
ledger and others nailed to wall studs**

Change Order: Install ten (10) additional LVL’s for structural support in the ceiling areas under the sitting area and adjacent room. Change Order = \$3,626

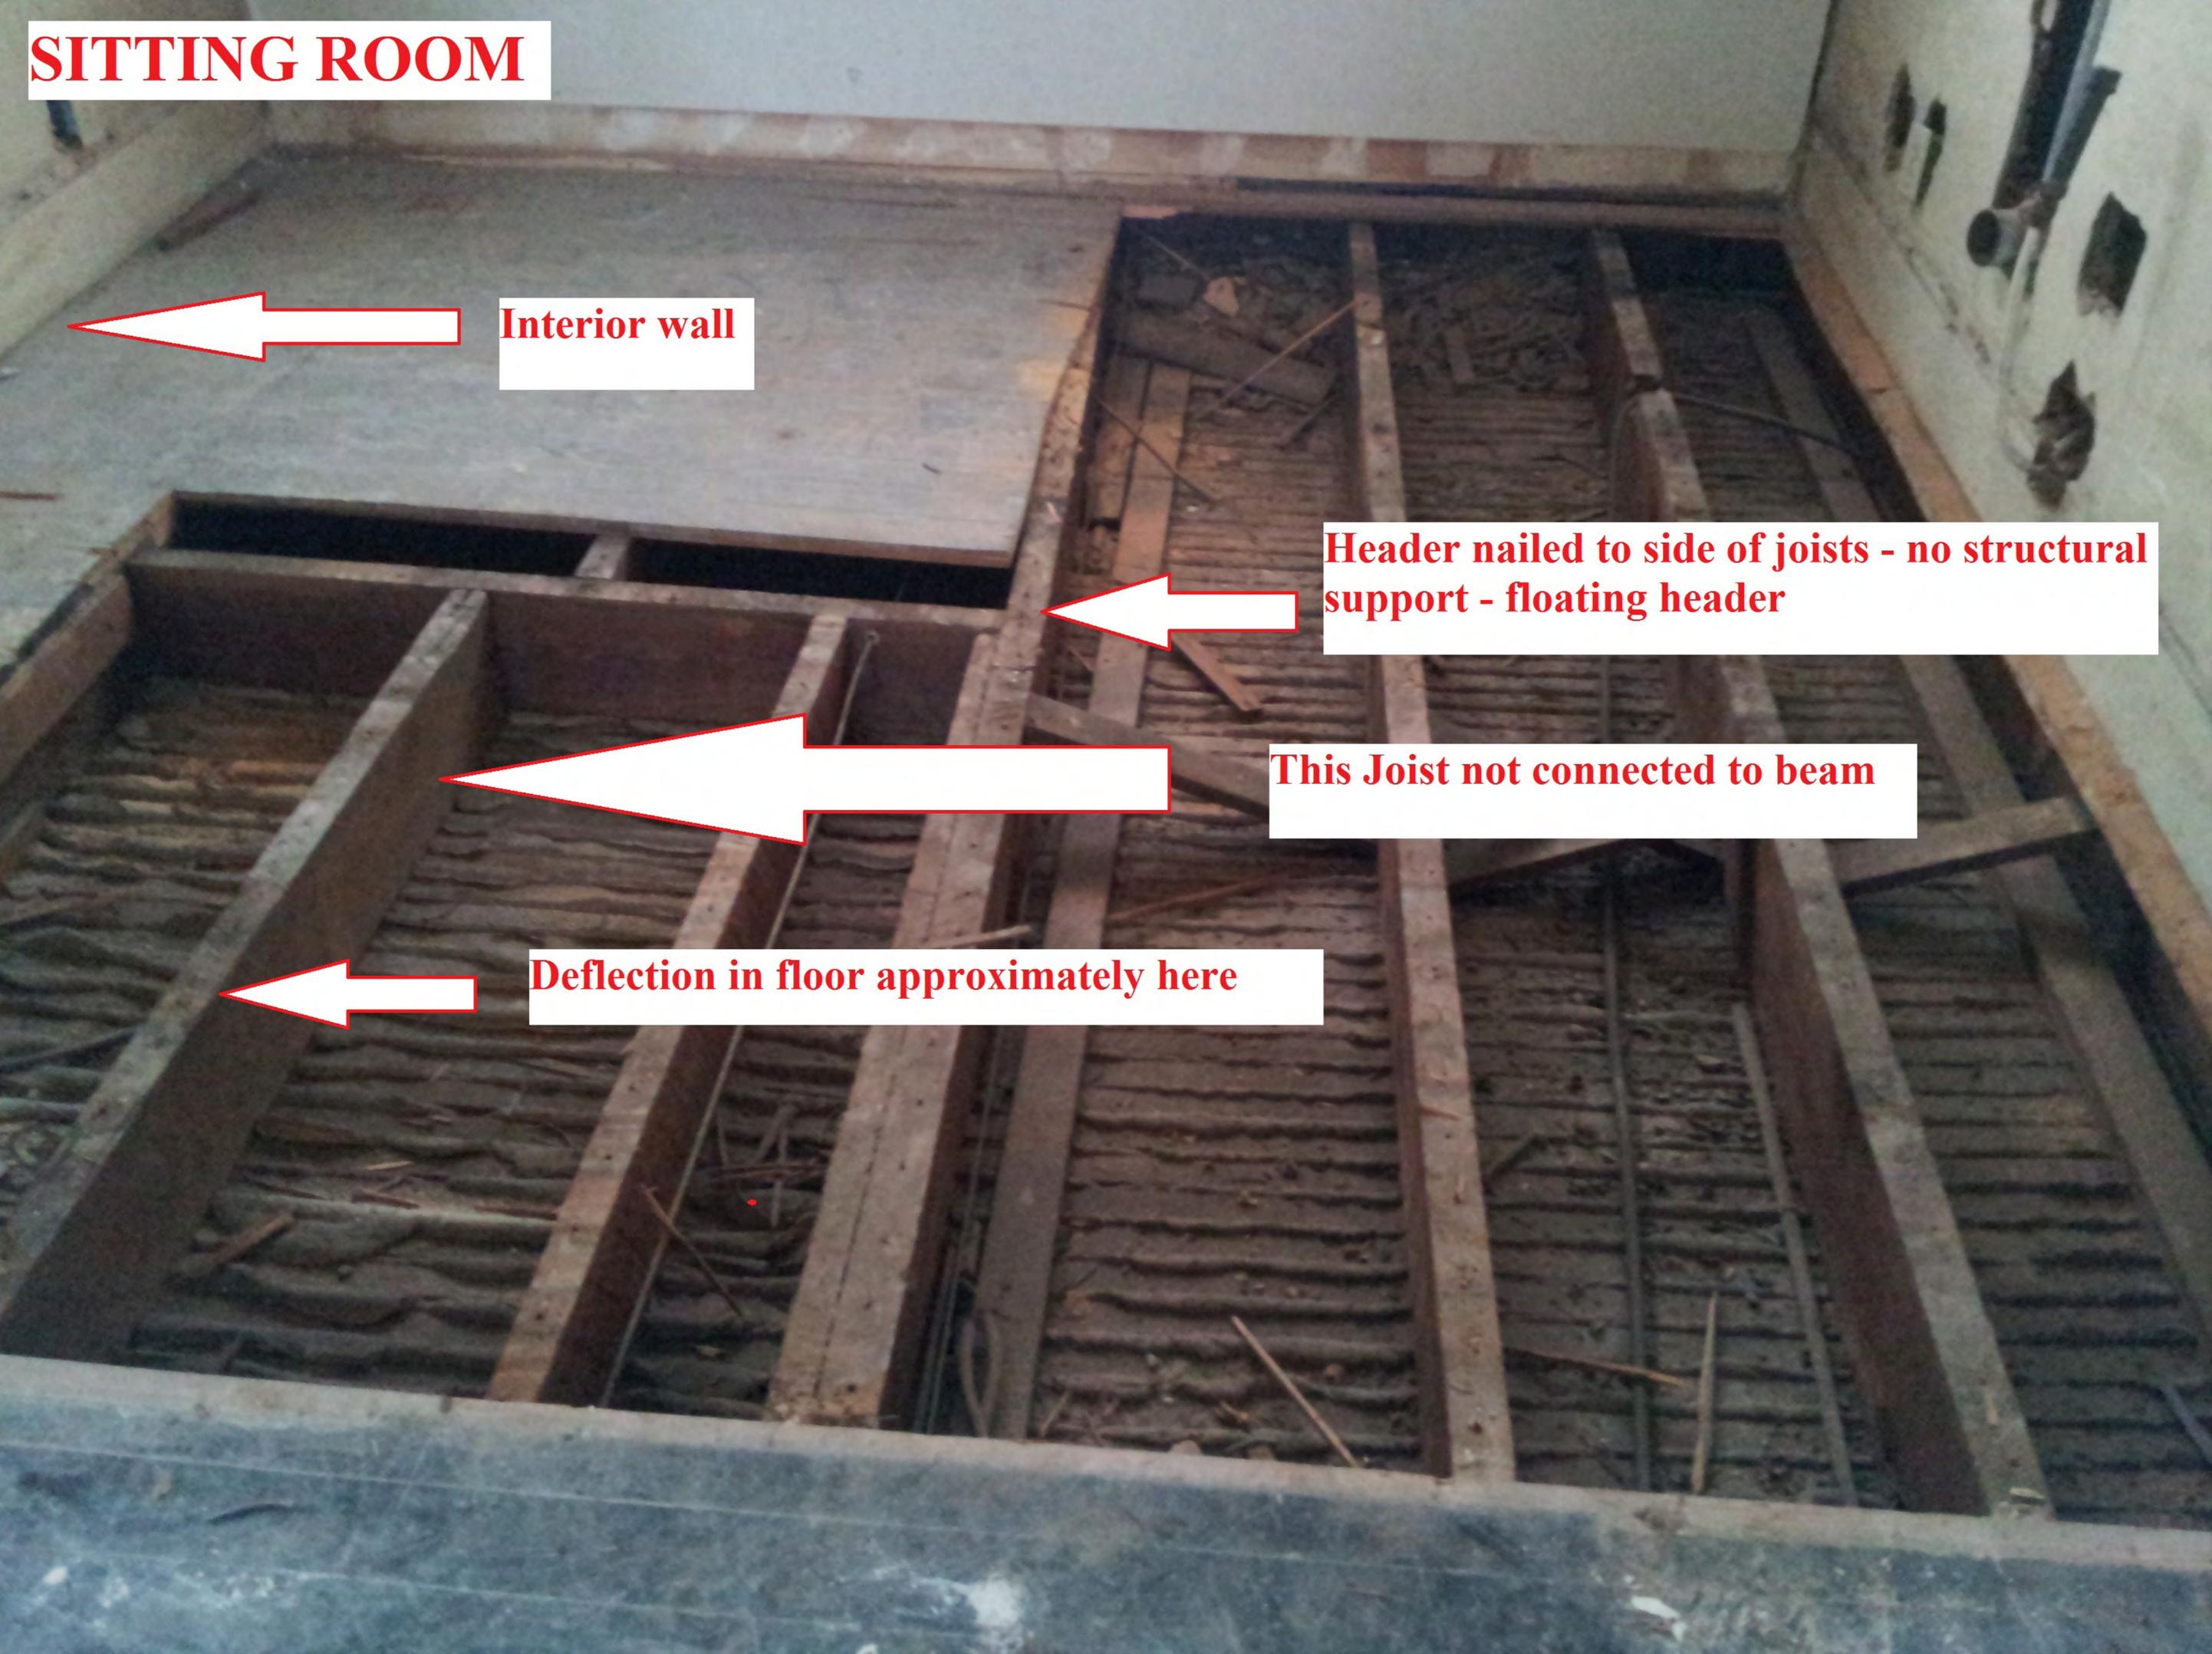
SITTING ROOM

- Abandoned heater flume encountered in the wall of the sitting room
- All flooring (non-historic) had to be removed in sitting room to observe structural floor support conditions. Underlying joists are recommended for structural reinforcement with LVL's including additional support under joist under interior wall – headers also observed to not be connected to beam – not included in the contract

← Interior wall

← Header nailed to side of joists - no structural support - floating header

← This Joist not connected to beam

← Deflection in floor approximately here

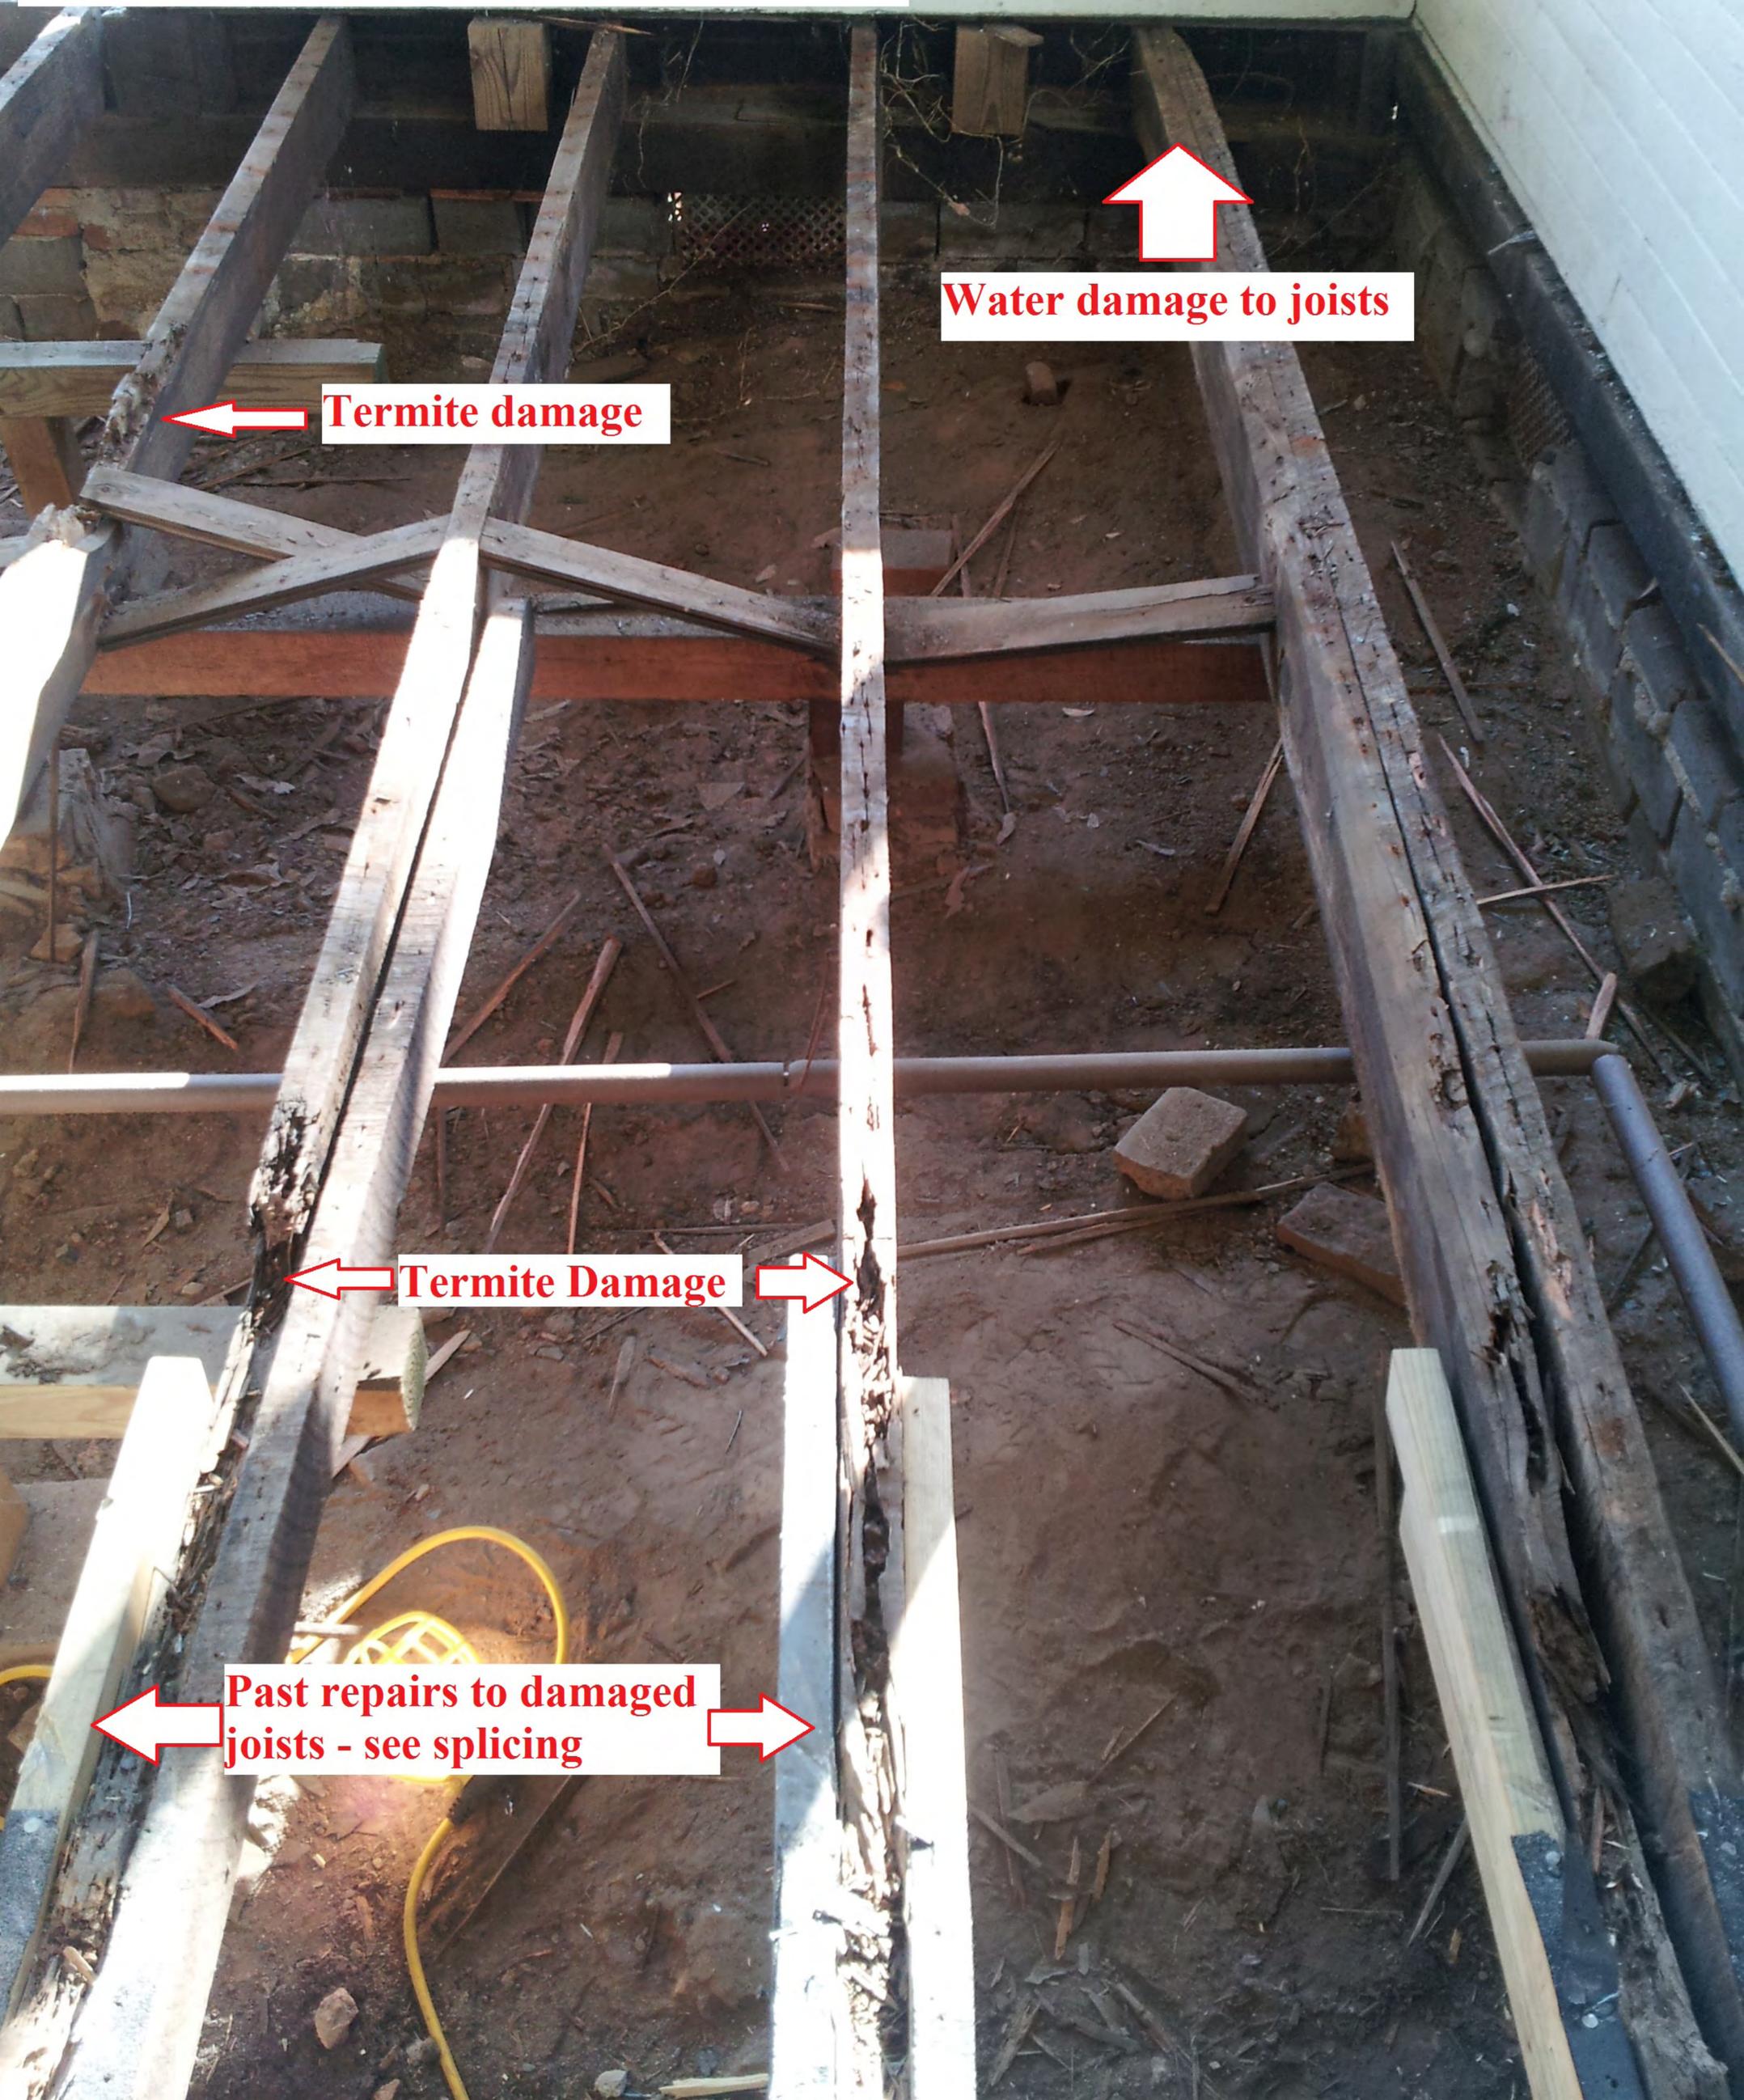
RECEPTION/WAITING ROOM AREA - formerly back porch and utility room

- Wall framing for restroom partially complete
- Patching wood columns completed
- Wood flooring removed in the reception and waiting area due to surface deterioration – exposed deteriorated joists and previous improper repairs (splicing of joists) – caused by water and termite damage – all joists and flooring recommended to be removed

↑
Water damage to joists

← **Termite damage**

← **Termite Damage** →

← **Past repairs to damaged joists - see splicing** →

Change Order: Remove the flooring and joist system in the reception (former back porch) and waiting area (former utility room) and replace with new joists (18). Change Order = \$2,611
