CLARKSTON CITY HALL ANNEX RENOVATION OF MORRIS FAMILY HOUSE

CITY MANAGERS PROGRESS REPORT #2

November 22nd to December 17th

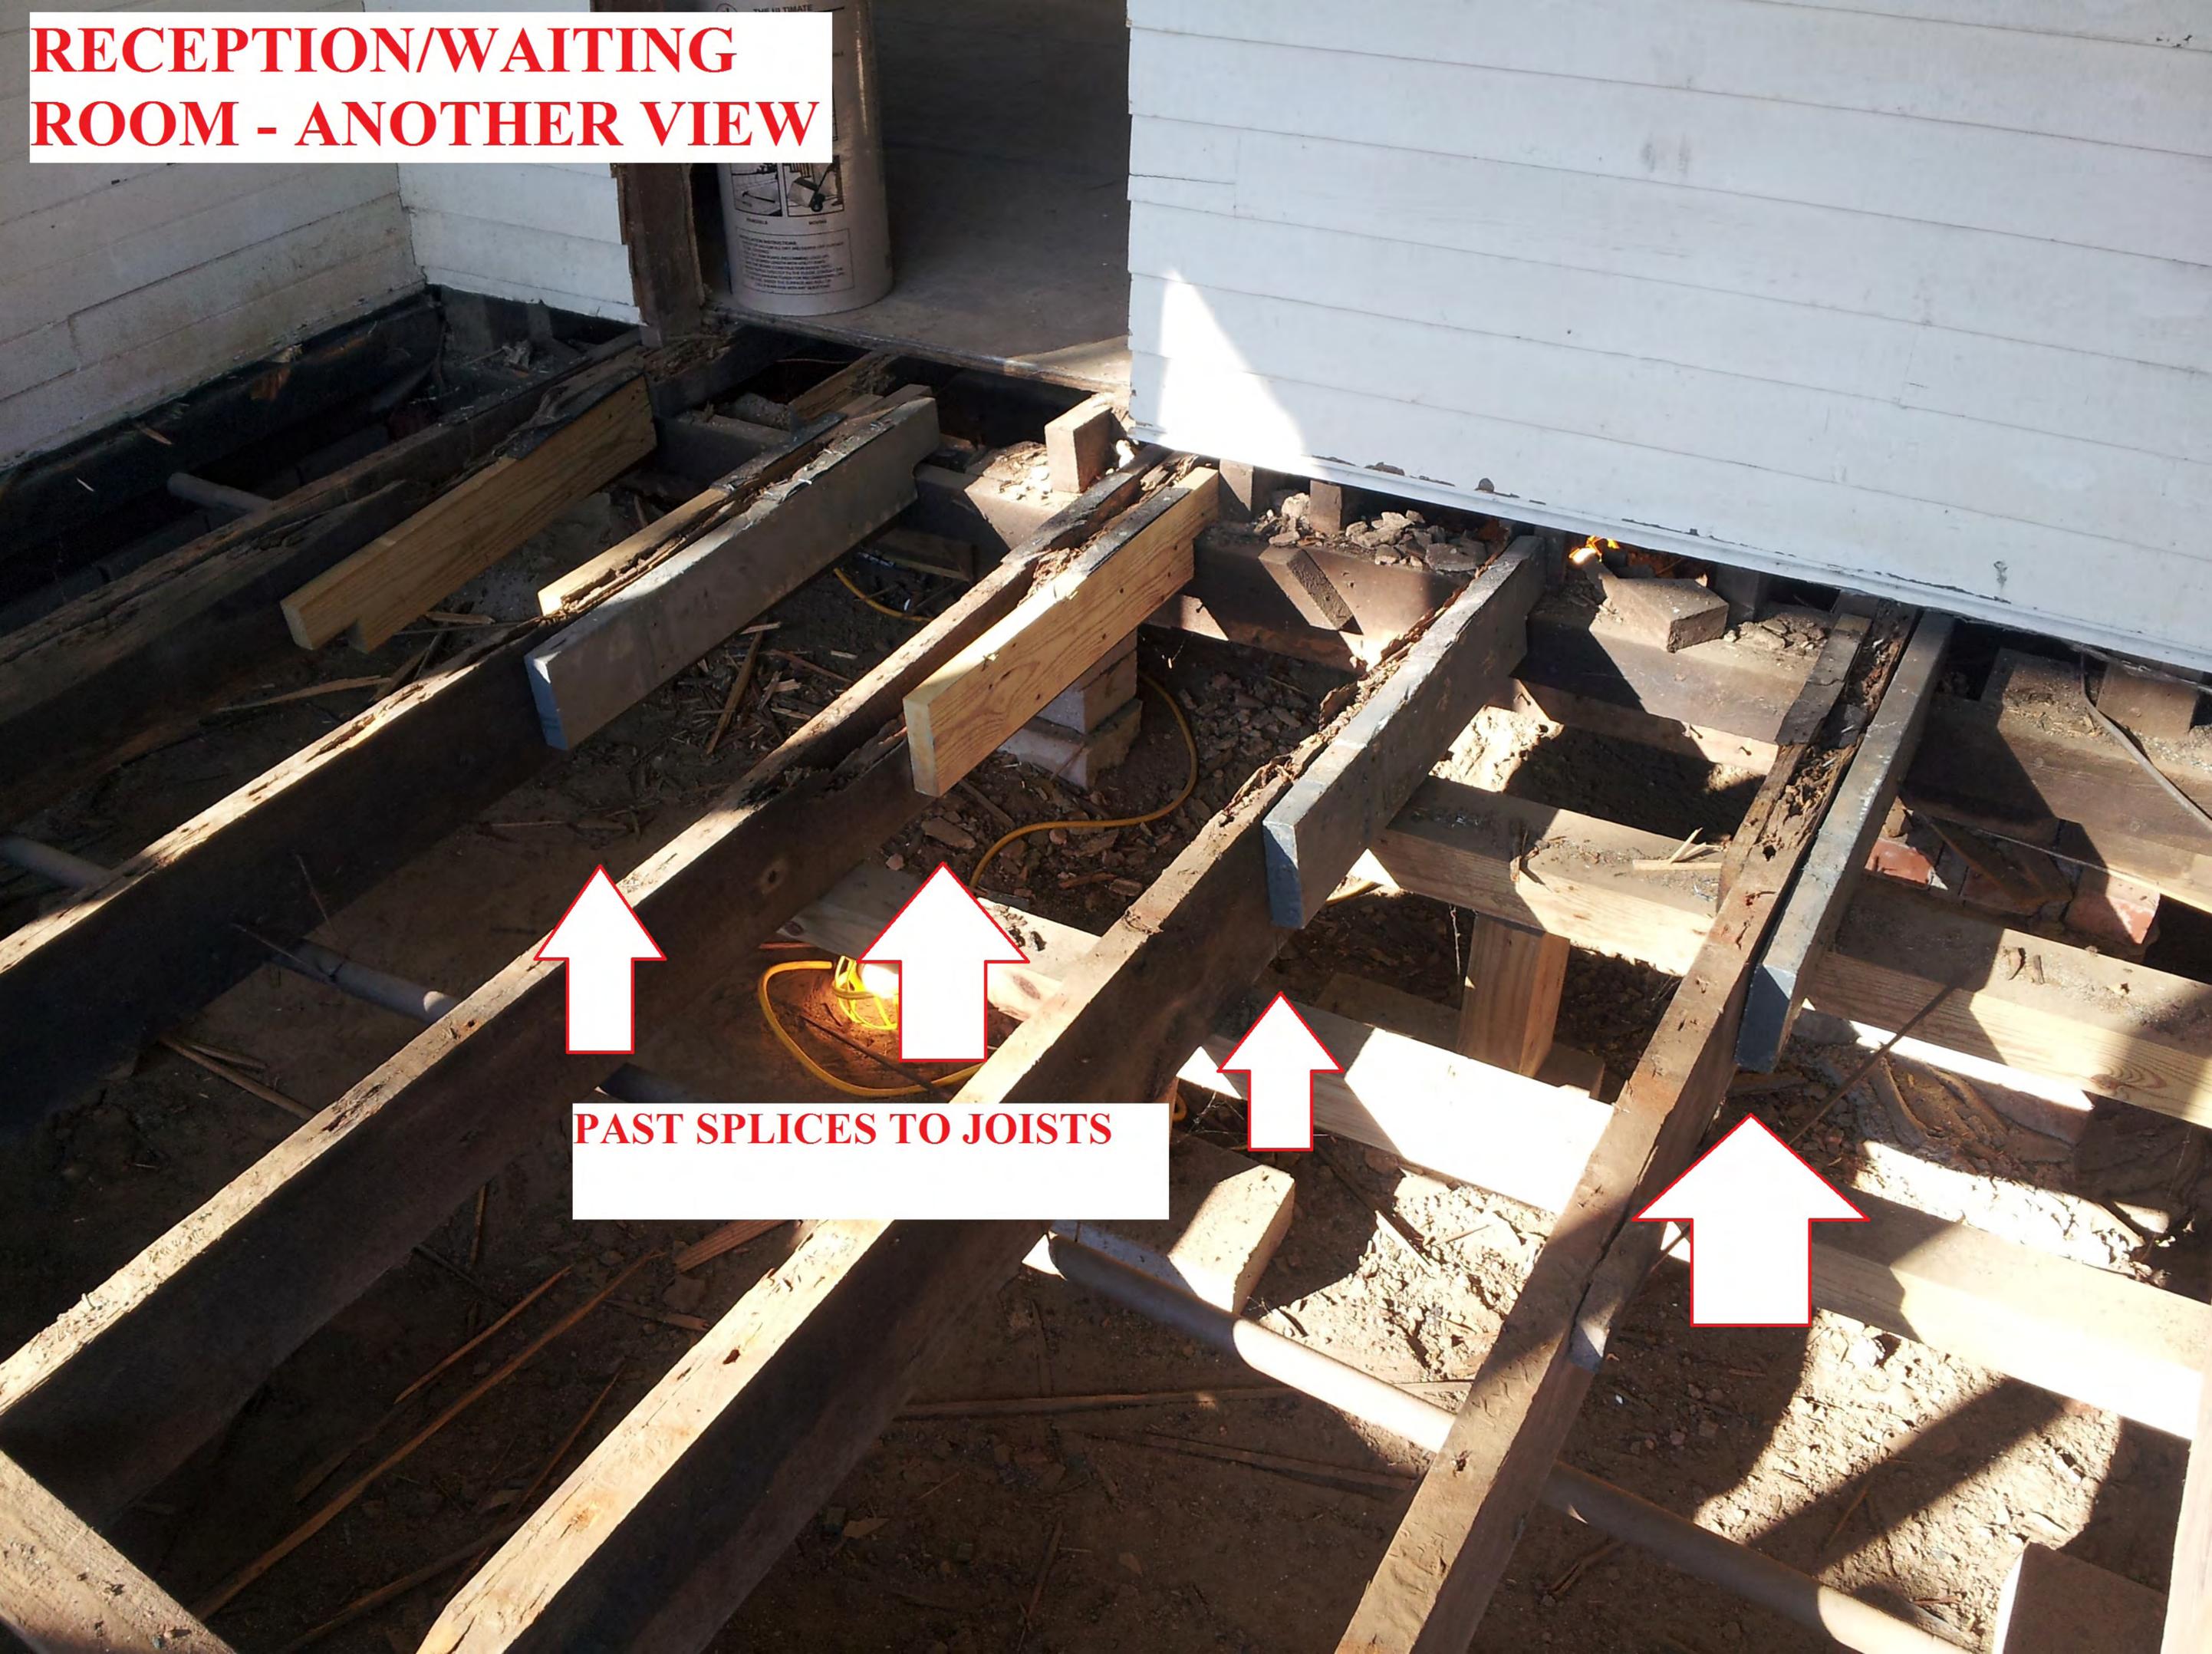
RECEPTION/WAITING ROOM - ANOTHER VIEW

PAST SPLICES TO JOISTS
