# **CLARKSTON CITY HALL ANNEX RENOVATION OF MORRIS FAMILY HOUSE**

CITY MANAGERS PROGRESS REPORT #6

March 22<sup>nd</sup> to April 24<sup>th</sup>, 2013

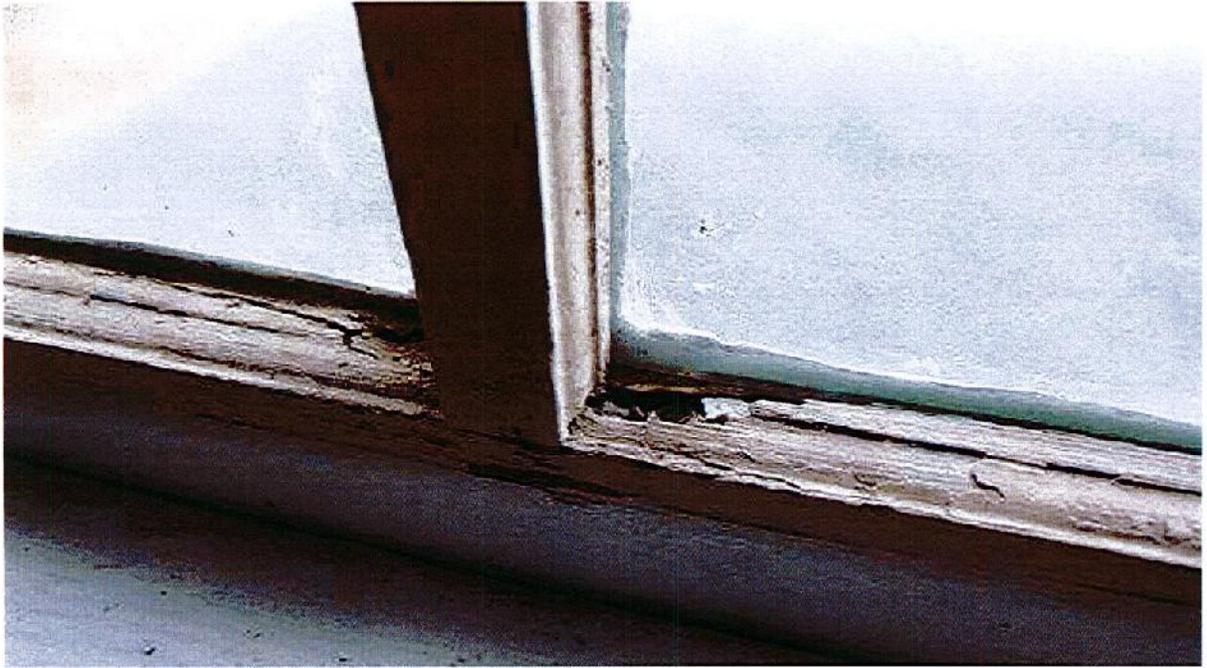
**Wood rot at window muntin**

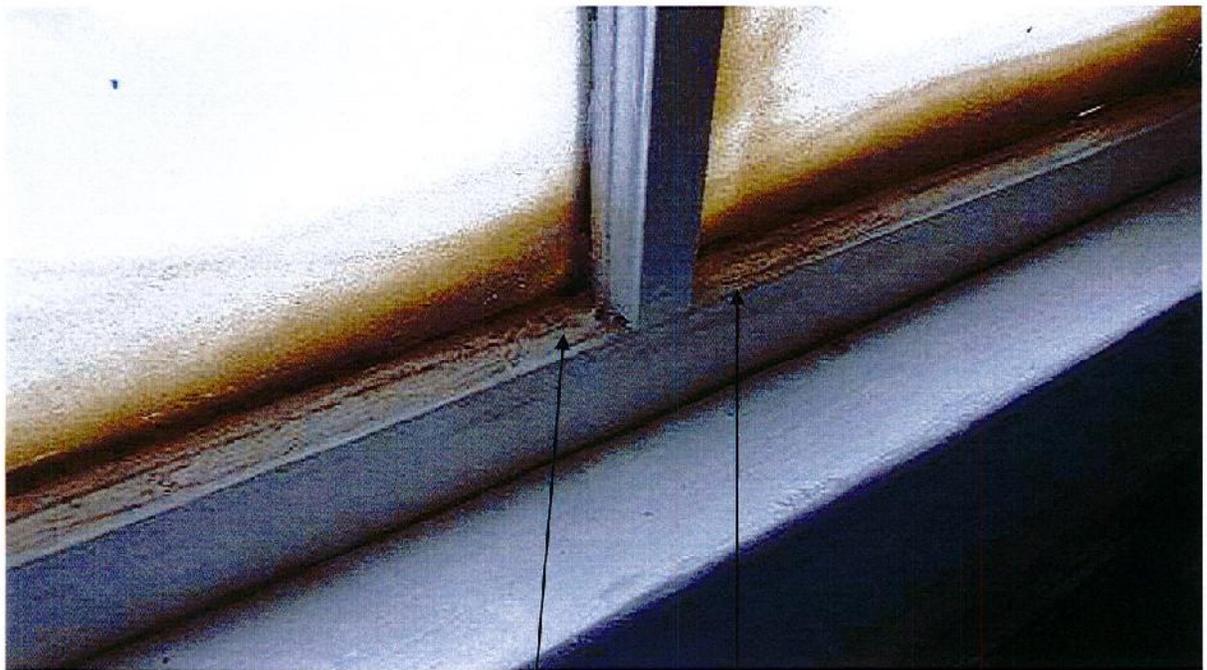
**Wood putty repair – muntin**

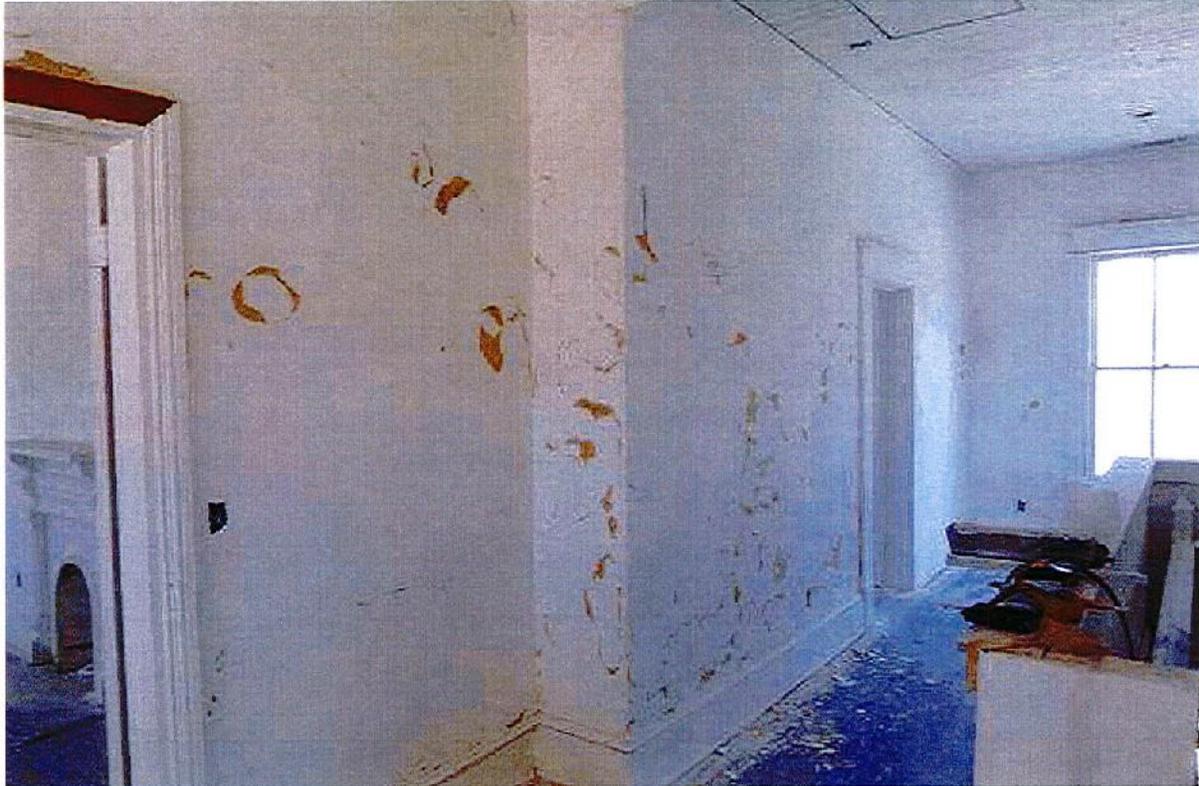
**2<sup>nd</sup> floor hallway – existing paint peeling – scraped and then peel more  
– unable to remove all existing paint without damaging existing  
plaster – use reinforcing mesh and plaster skim across entire length of  
wall (change order)**

- Metal lathe and complete refinishing east wall 2<sup>nd</sup> floor hallway - unable to remove paint from existing plaster wall
- Replace missing molding and door trim 2<sup>nd</sup> floor hallway

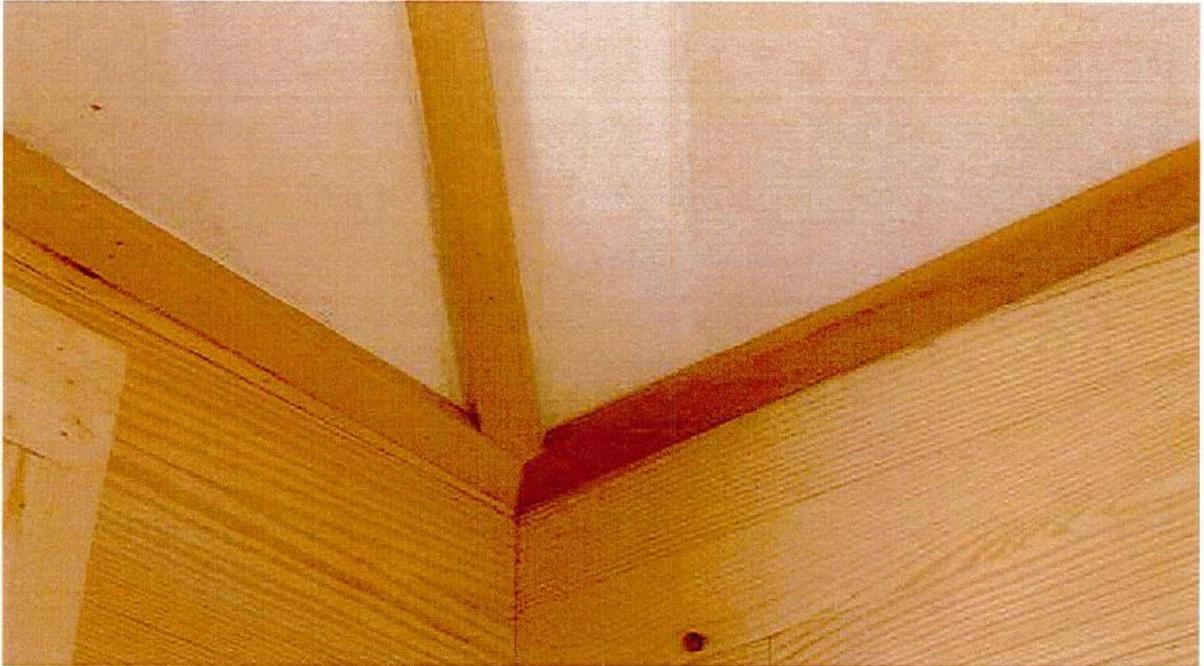
**Ceiling trim reworked – initial placement unsatisfactory**

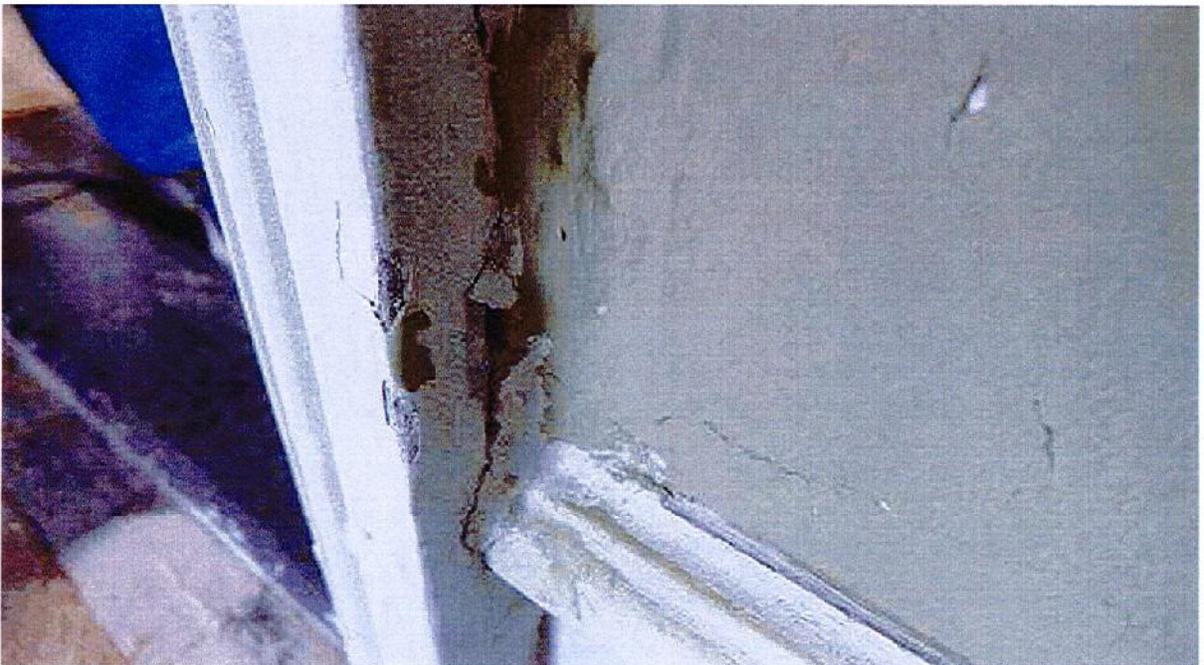
**Loose material at wall and trim (typical throughout house – attention to detail required of the contractor)**

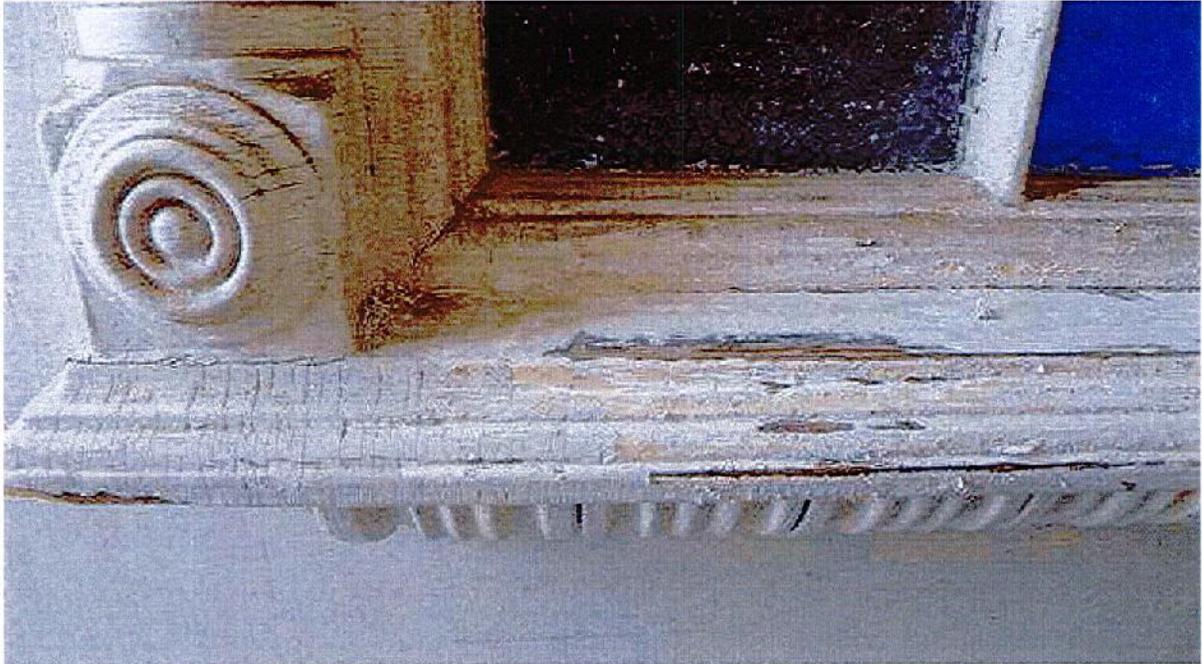
**Front door – attempted to remove paint – no paint removal products successful – door taken off site to speciality door company to refurbish and remove 6 layers of paint**

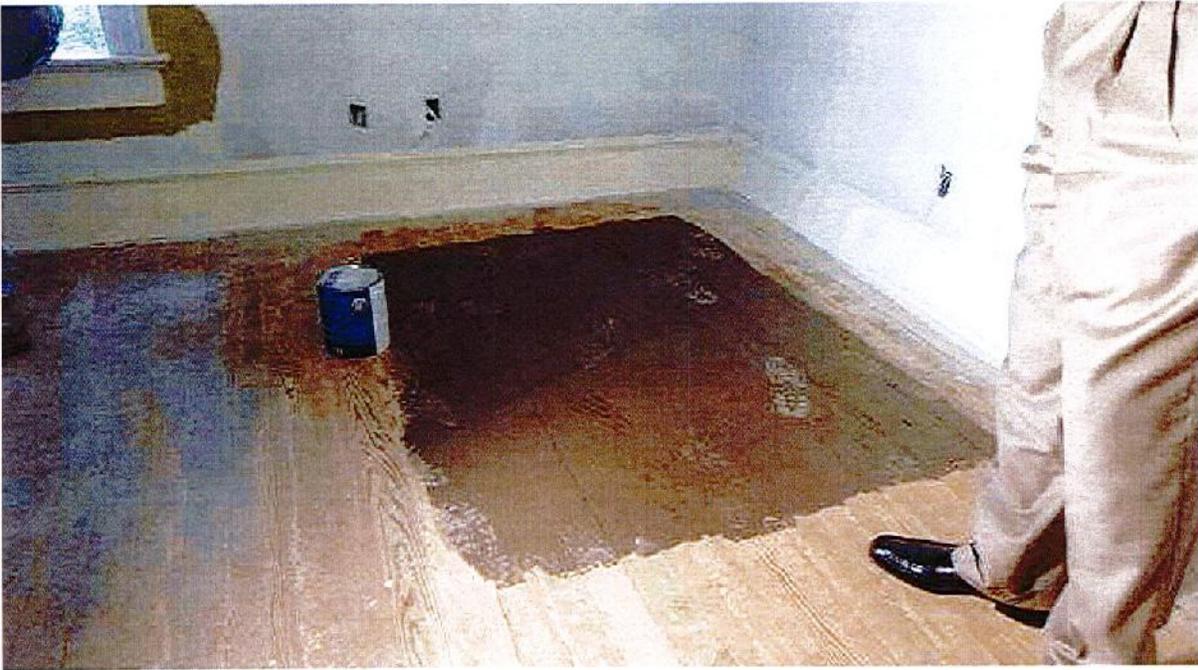
**Floor paint mockup – flat paint (assessing gloss as of 4/24)**

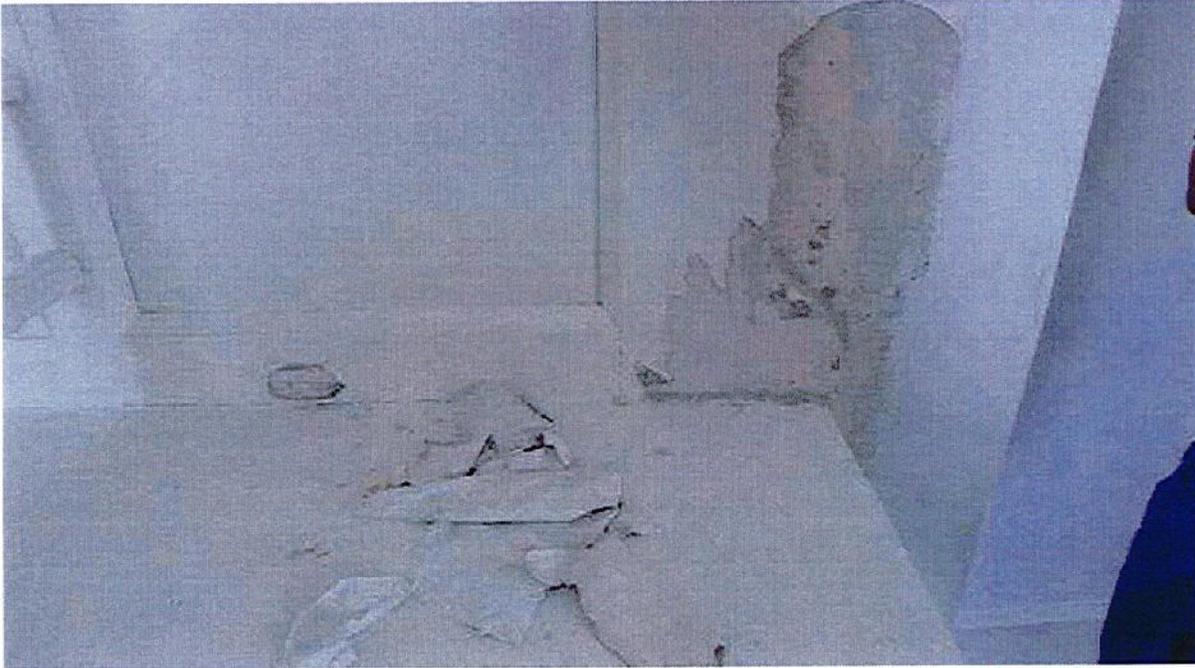
**Wood mantel – paint adhesion problems (linseed oil paint also)**

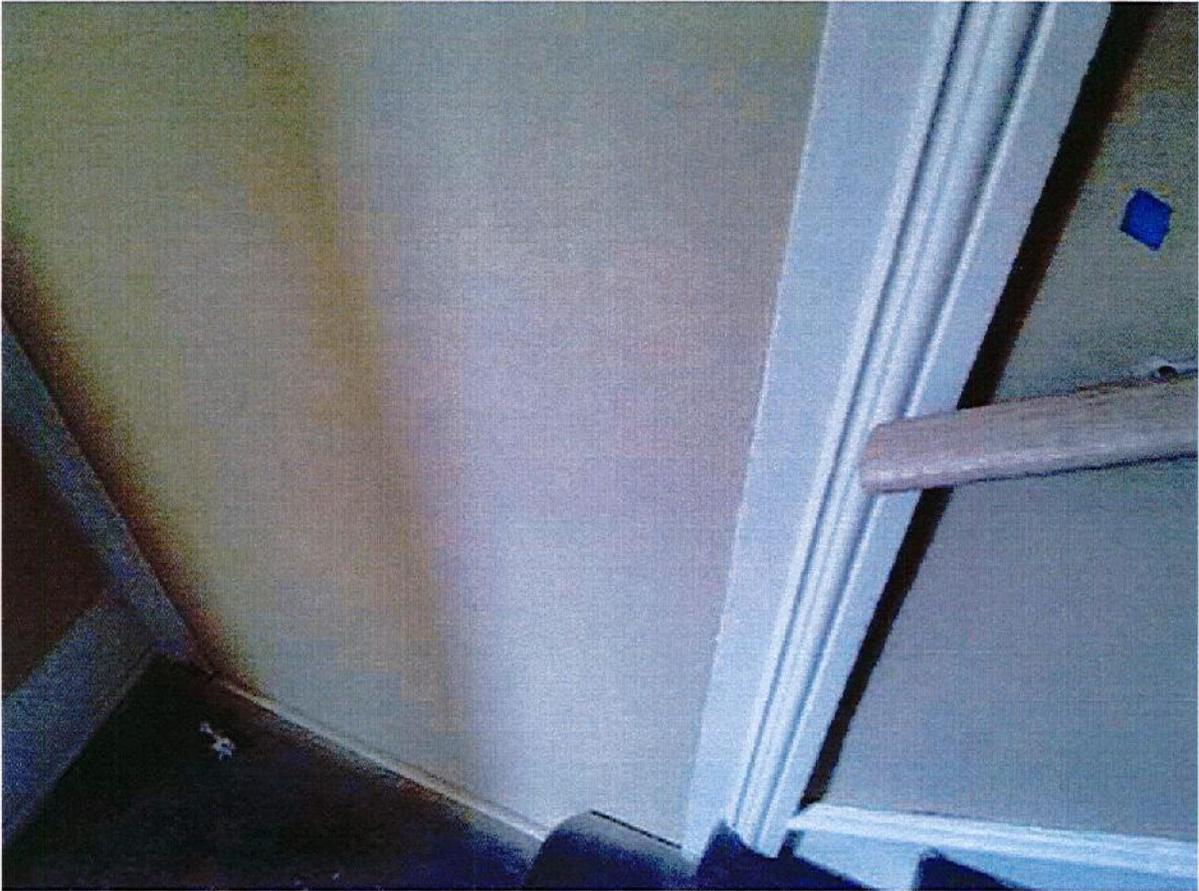
**Newly installed handrail not to code (repair required)**

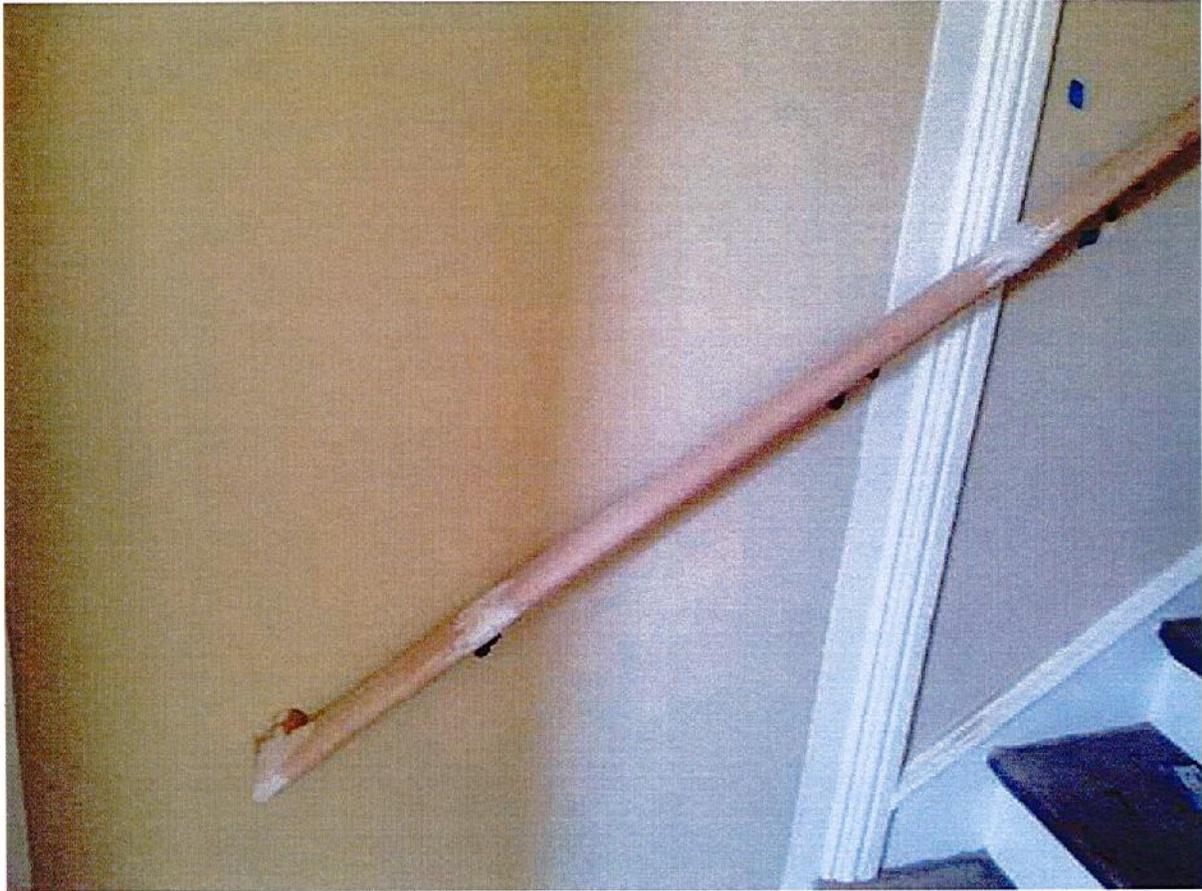
**After handrail repair**

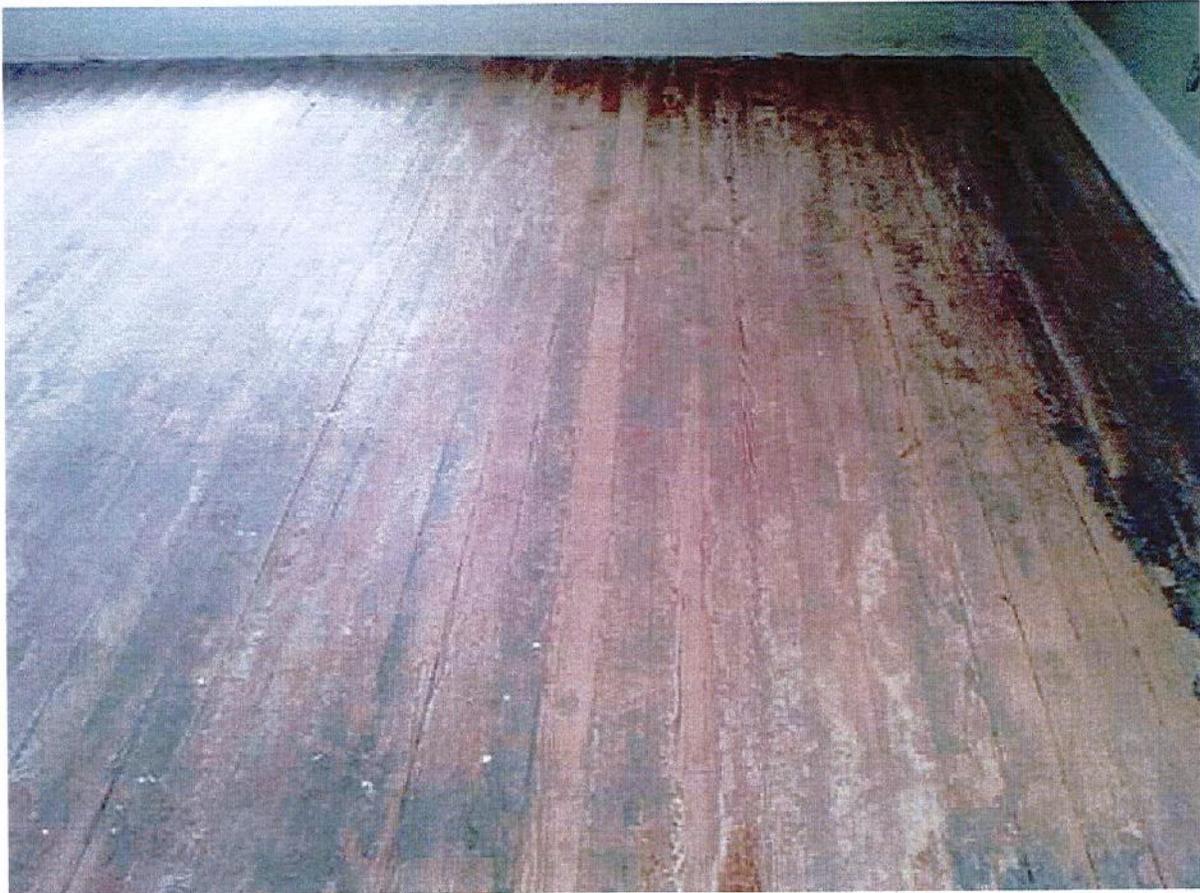
**Upstairs office – padding for rug removed – padding imprint into wood floor – additional sanding required – green stain exists now but will be covered with brown paint**

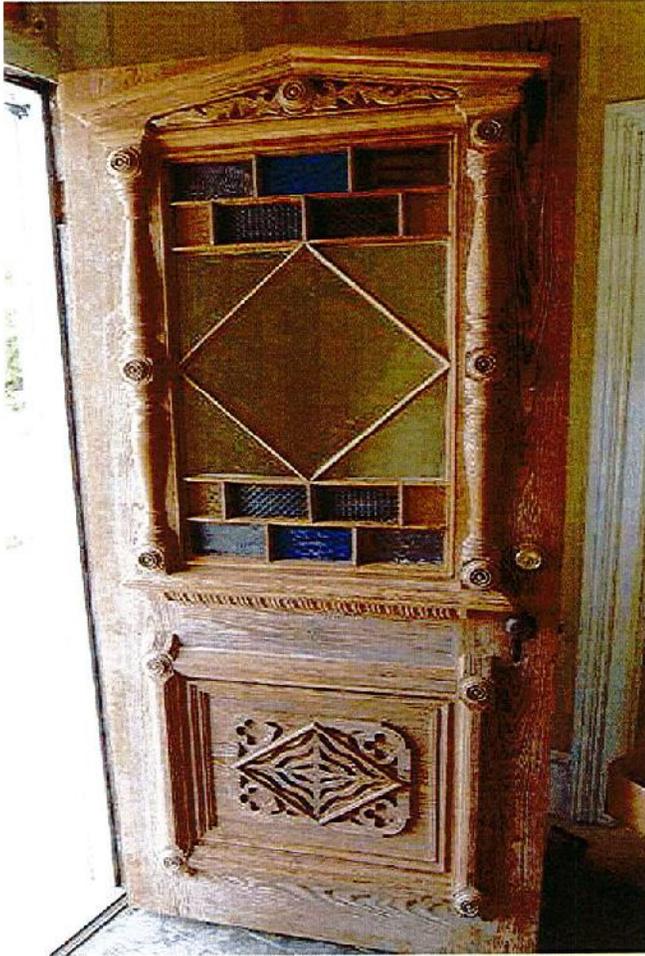
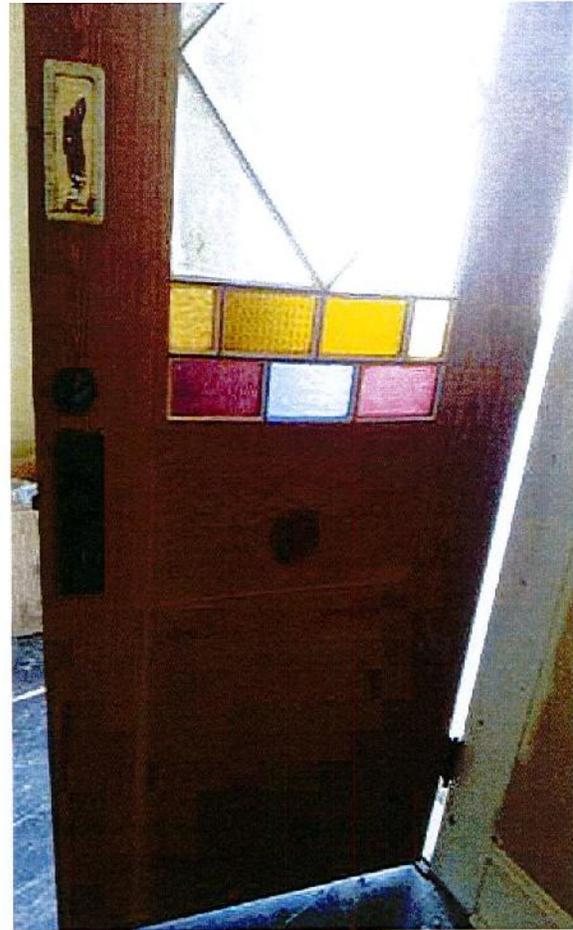
**Front door – Nicaraguan Pine (1890’s vintage) – 6 layers of paint removed by architectural restoration specialist (Peruvian native with 100+ years of wood working/shipping in family). Restoration took 10 days. Restoration occurred off-site. Architectural assessment of door occurred after paint was removed. Painting contractor and architect stated that wood staining in late 19<sup>th</sup> or early 20<sup>th</sup> century did not occur. Architect stated that door required priming within 1-2 days after arrival from shop to ensure untreated wood would not experience a prolonged period of moisture exposure. Untreated aged wood has a tendency to crack/accelerated deterioration (i.e. mummy’s exposed to the air/moisture disintegrates at a greater rate). Paint color for door likely to be a “brown”. Specific “brown” tone TBD. Paint will accentuate the various architectural features much like staining since existing paint layers are now removed.**

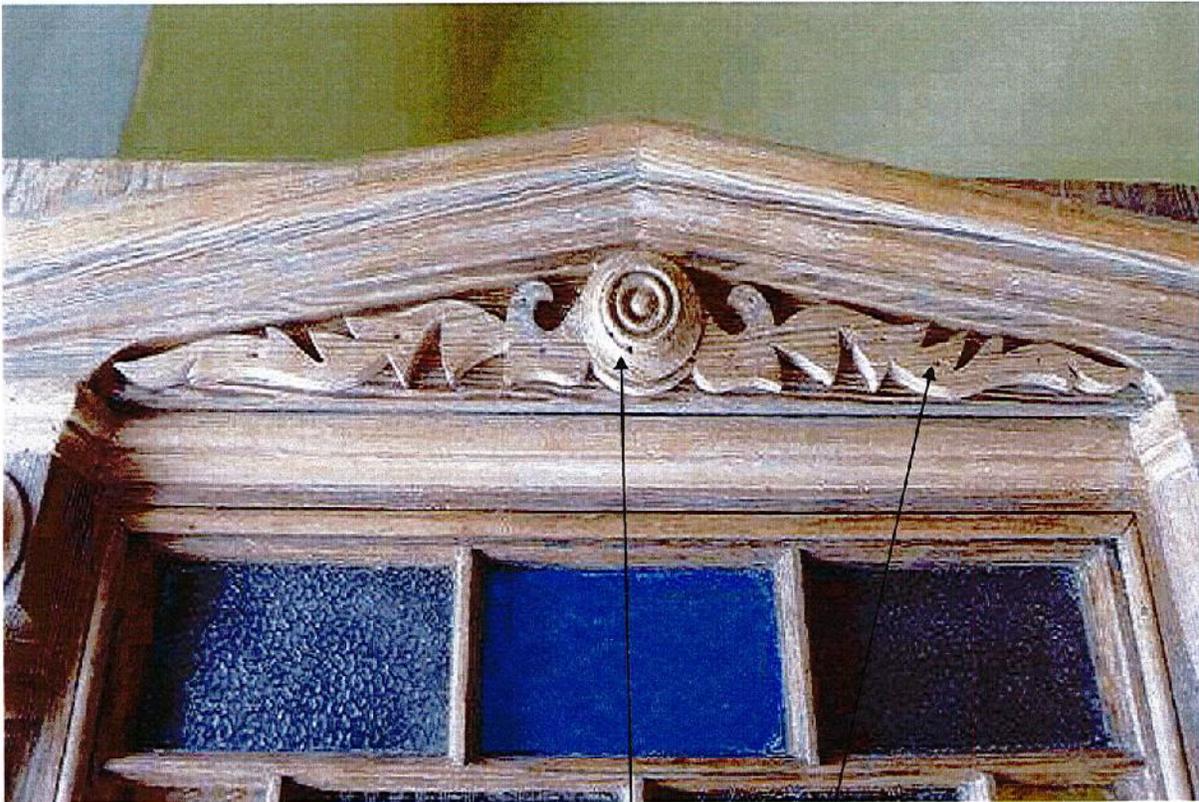
**pin holes**

**See pin holes (nails/imperfections in wood, etc) – to be lightly sanded and minimal use of wood putty**

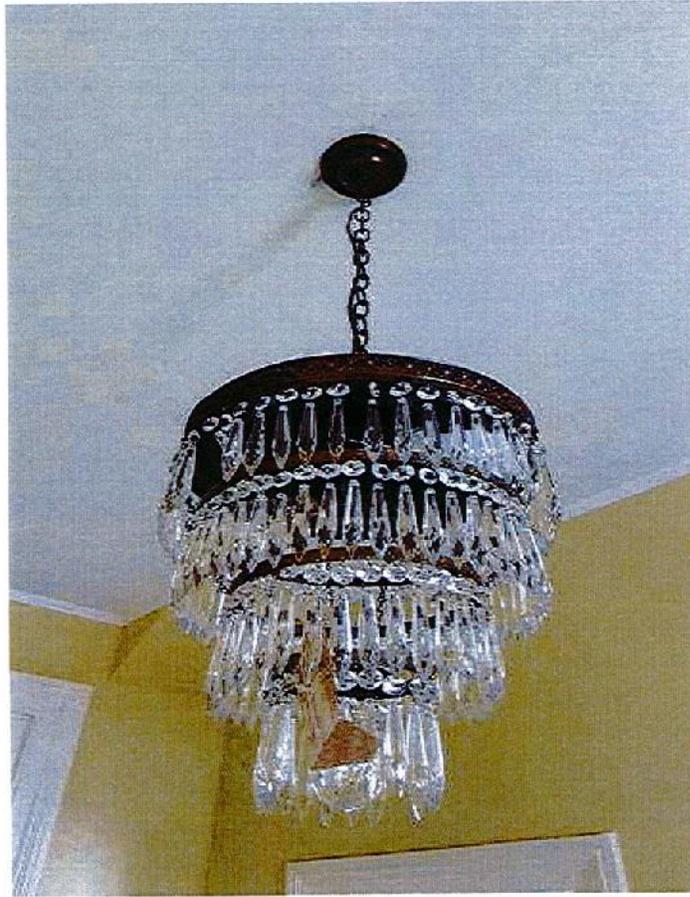
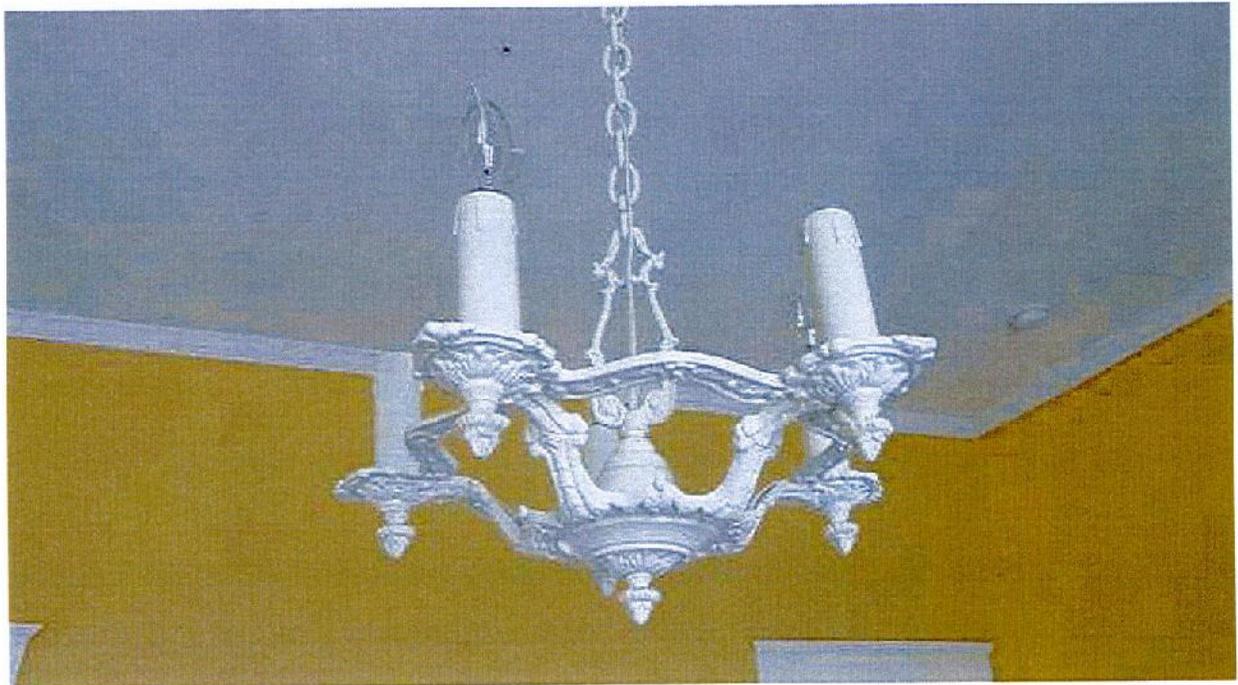
**Restoration of light fixtures – downstairs hallway and 1<sup>st</sup> floor office**
