# **CLARKSTON CITY HALL ANNEX RENOVATION OF MORRIS FAMILY HOUSE**

**CITY MANAGERS PROGRESS REPORT #7**

**April 25<sup>th</sup> to May 24<sup>th</sup>, 2013**

PROJECT: Clarkston City Hall Annex (Morris House), BA# 2012-04  
DATE: May 13, 2013

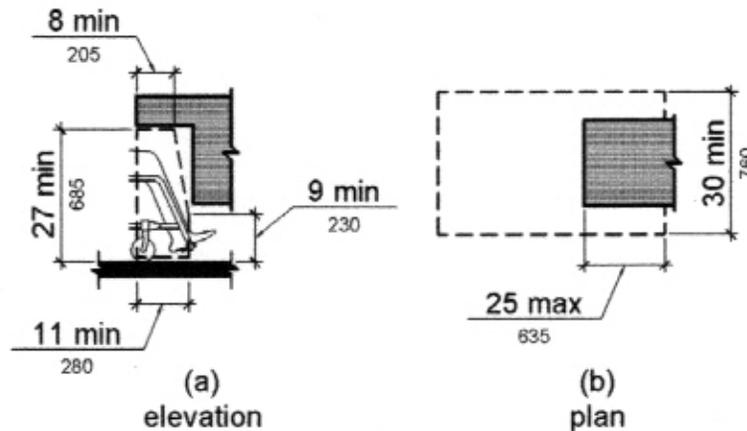
**Figure 306.3**  
**Knee Clearance**

- F. Angled skirt board installed at Break Room sink does not meet the clearance requirements of ADA; see attached Section 306.3 Knee Clearance for dimensional requirements under accessible sinks. If skirt needs to be removed to provide accessibility, install protective wrap at under-sink piping.

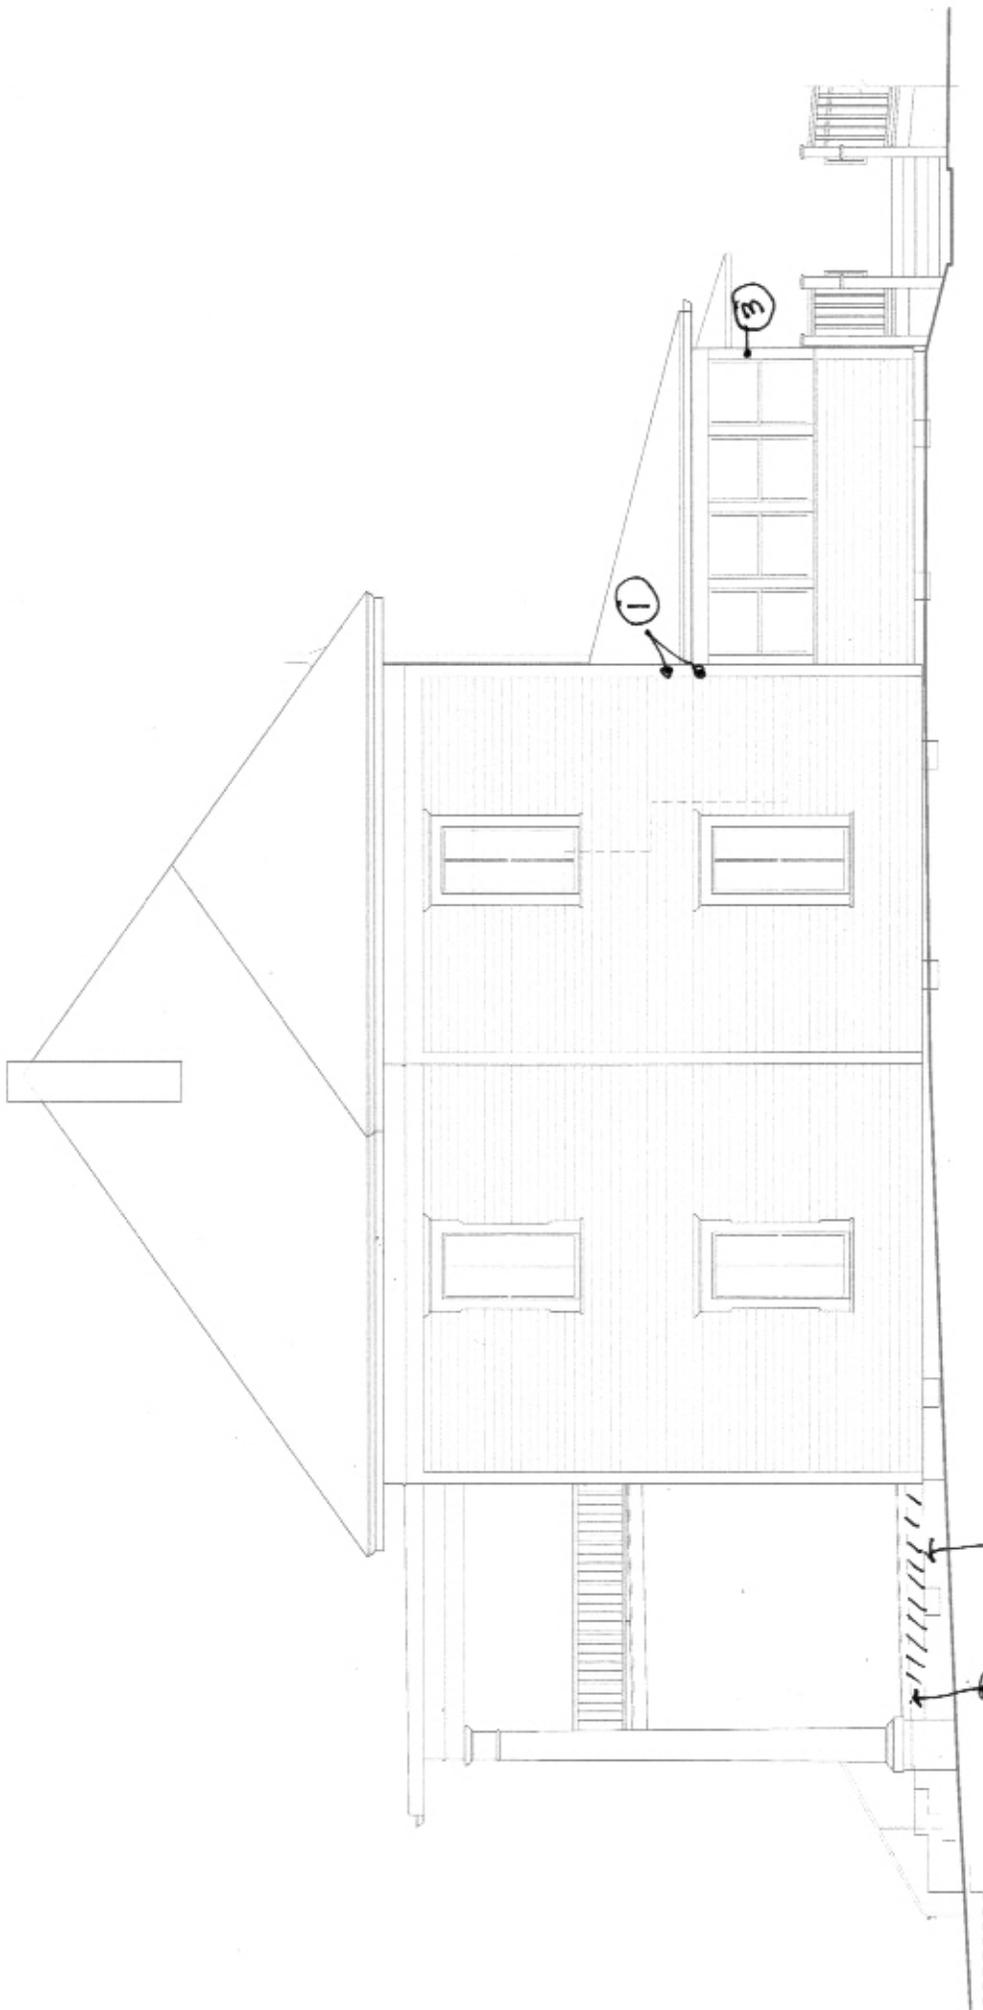
SOUTH ELEVATION

3 gray color  
@ skirt, top.
