# **CLARKSTON CITY HALL ANNEX RENOVATION OF MORRIS FAMILY HOUSE**

**CITY MANAGERS PROGRESS REPORT #4**

**January 26<sup>th</sup> to February 22<sup>nd</sup>, 2013**

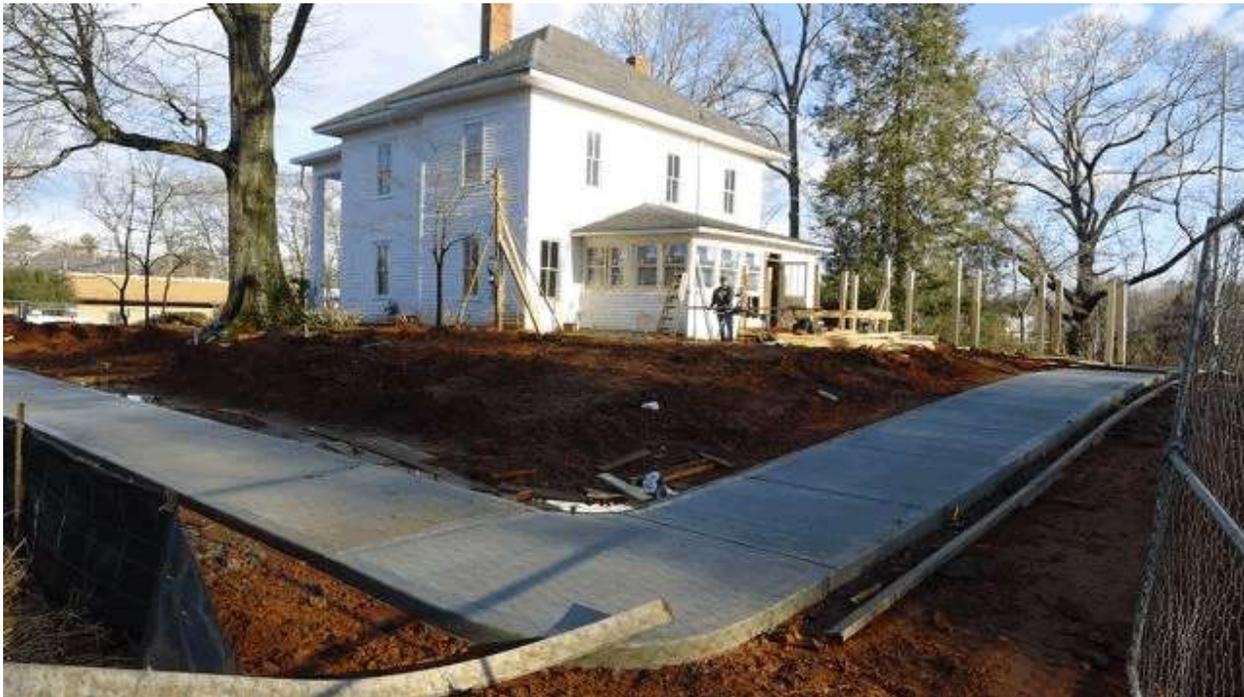
**Sidewalk Construction Completed**

**Market Street sidewalk and interior sidewalk to ADA ramp**

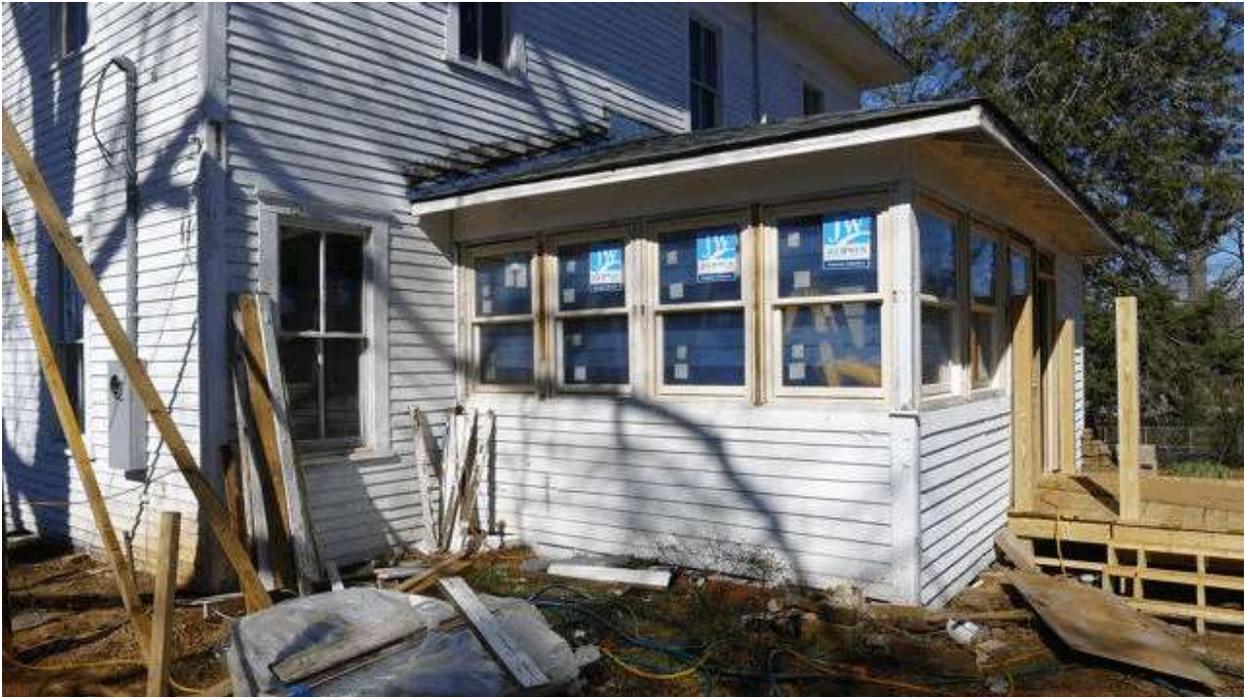
**Back Porch Exterior – see new windows**

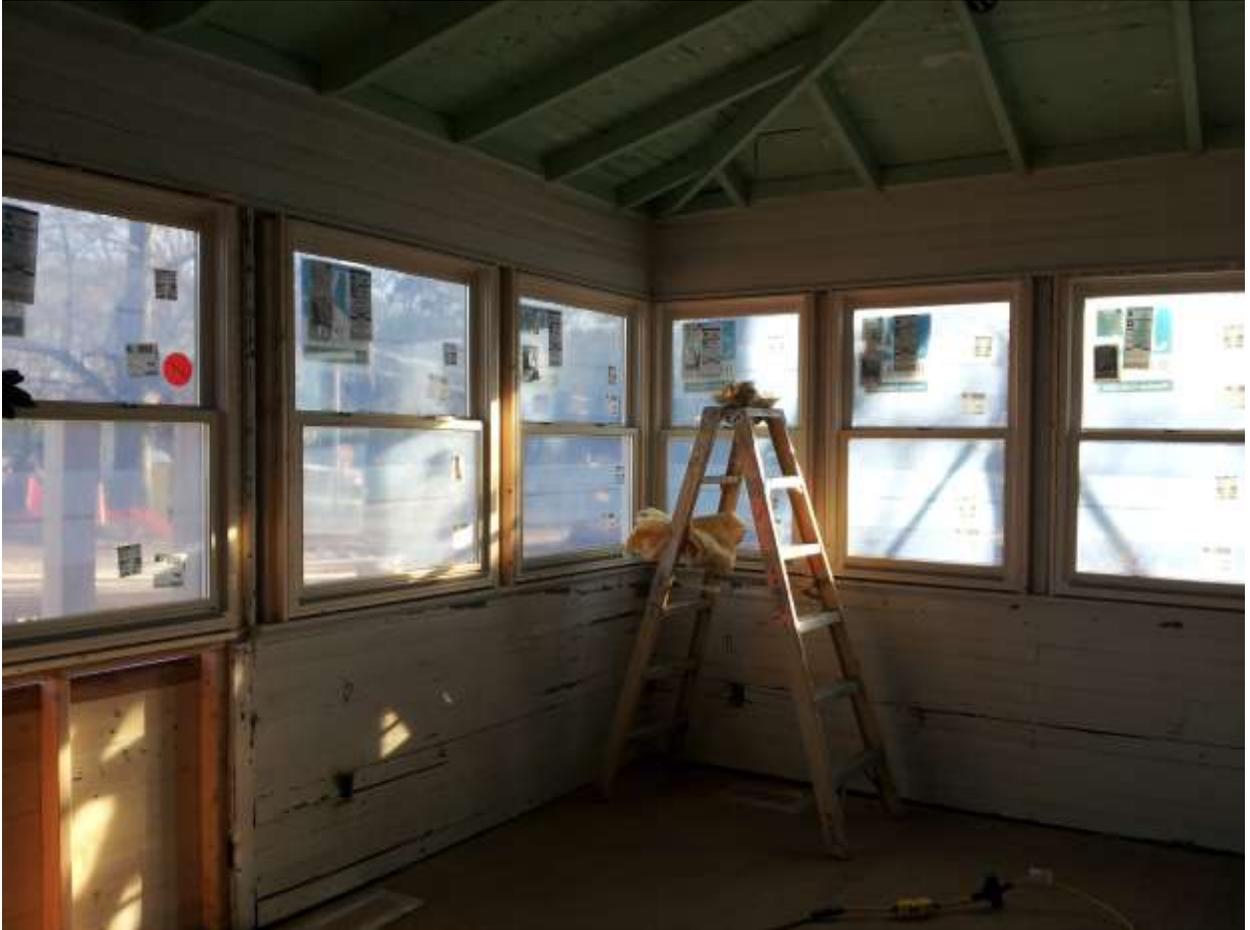
**Back Porch Interior – see new windows**

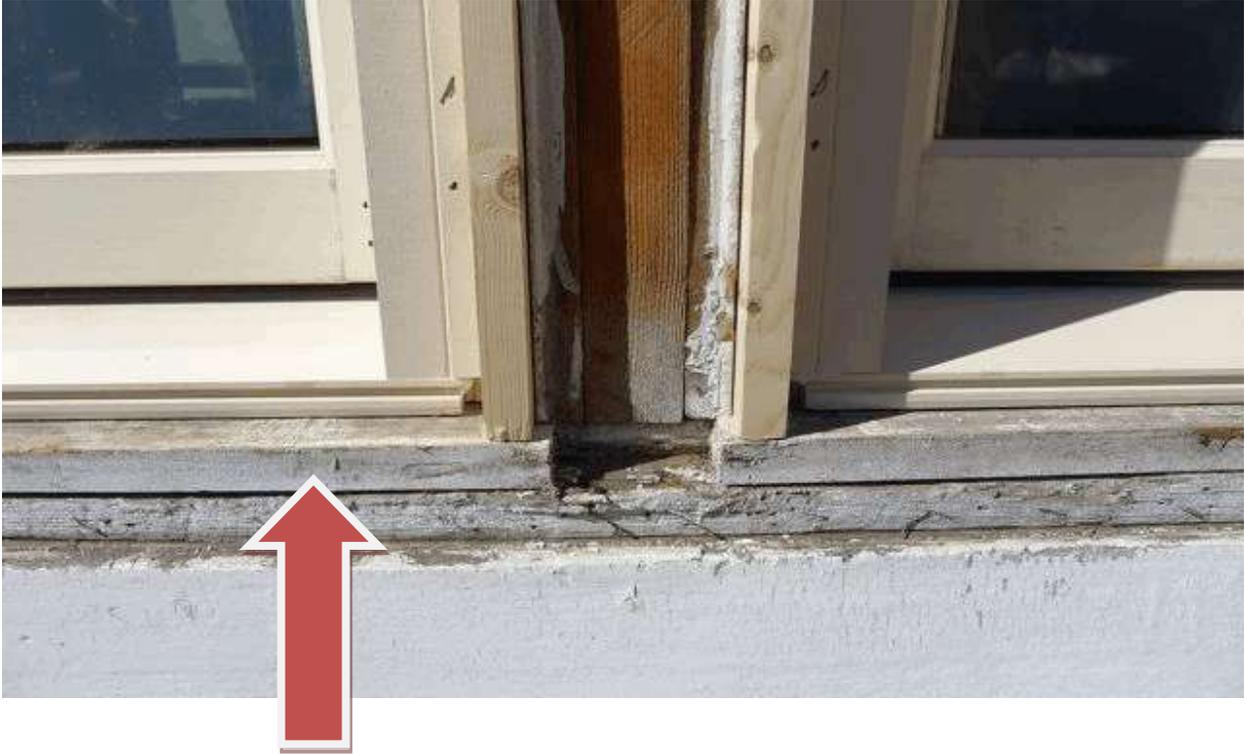
**See window sill – no sloped subsill (corrective action by contractor required to avoid wood deterioration/decay over time from water)**

- ✓ New window installation in reception/waiting area to be resolved – existing exterior framing not plumb & resolution to slope of window subsill and entrance door framing
- ✓ Pressure treated posts for ADA ramp – posts bent from curing – wood post supplier to respond to defect

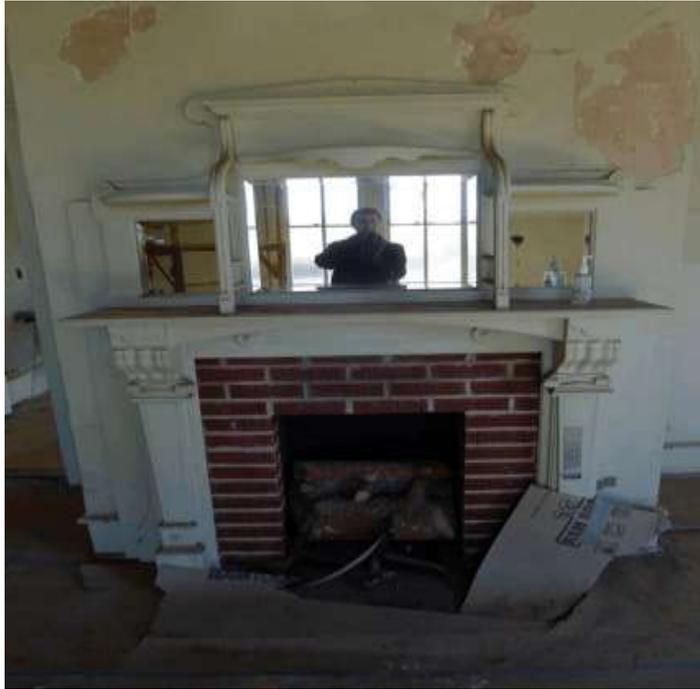
**Conference room chimney – red brick to receive new ceramic tile, surfaces within firebox to be painted black and mantel to be painted interior trim color (typ.)**

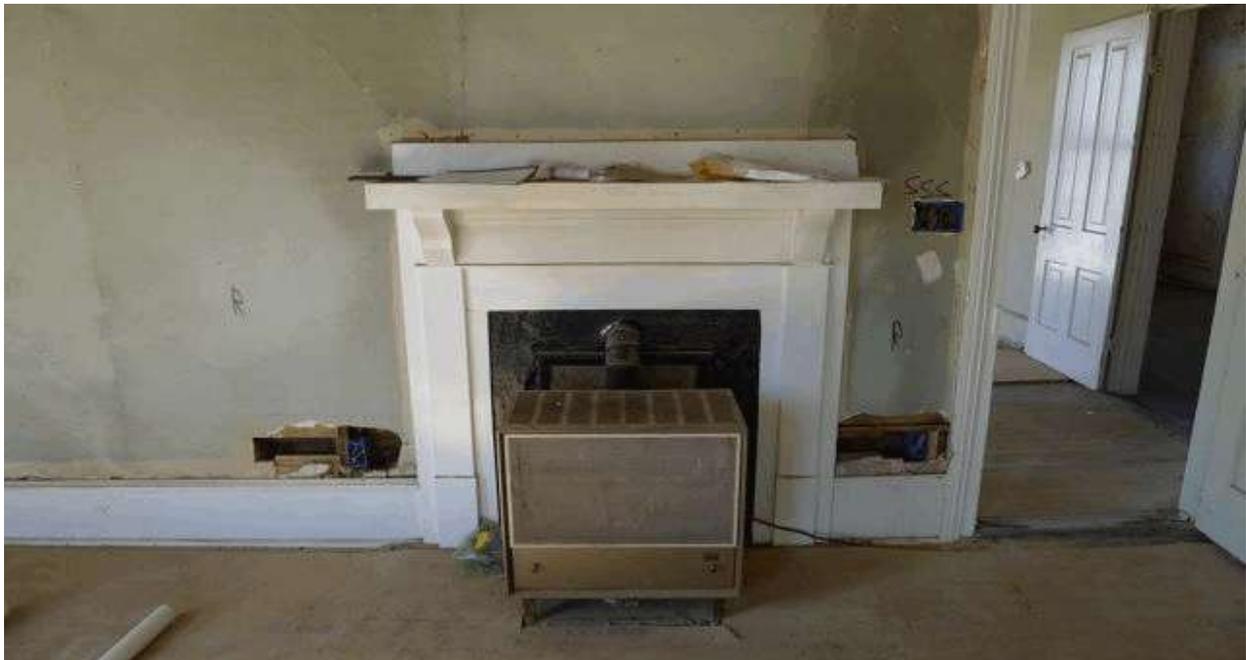
**Work/Kitchen Room – heater and hose to be removed (completed) – flue opening to be capped and filled flush (typical in all rooms)**

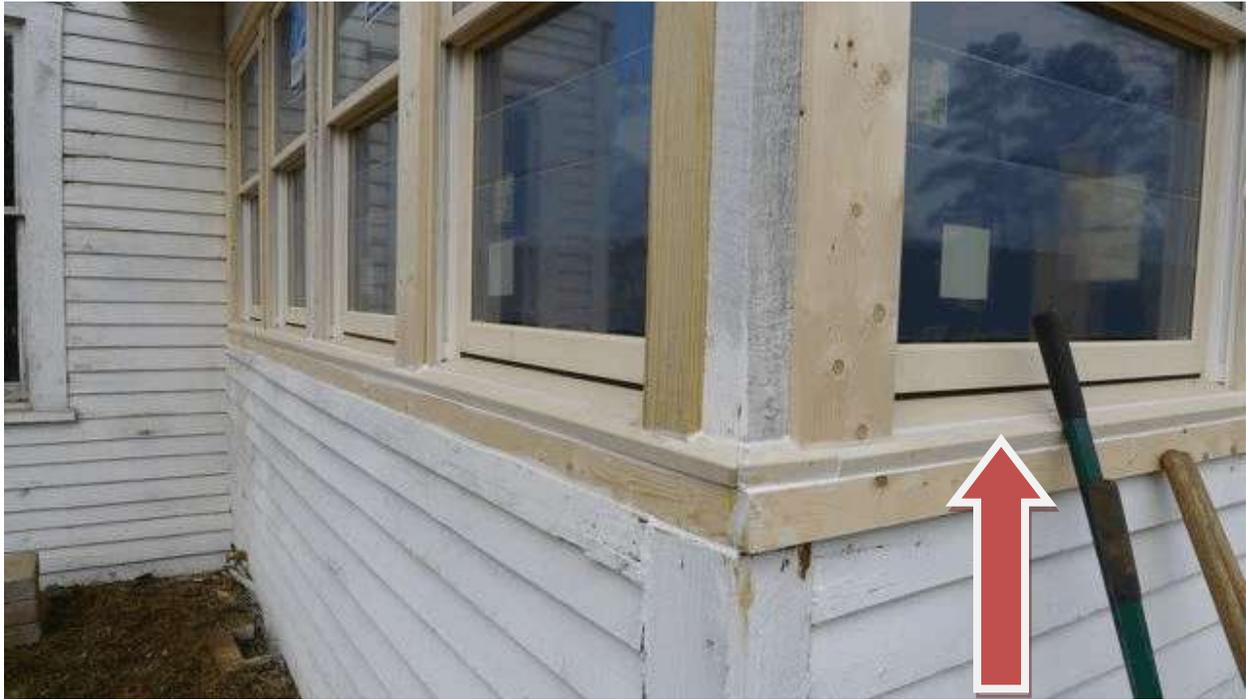
**Lack of slope on subsill to be resolved by contractor – either reset windows or place a 1 x 2 pressure treated section under subsill to allow for positive drainage (see following pictures)**

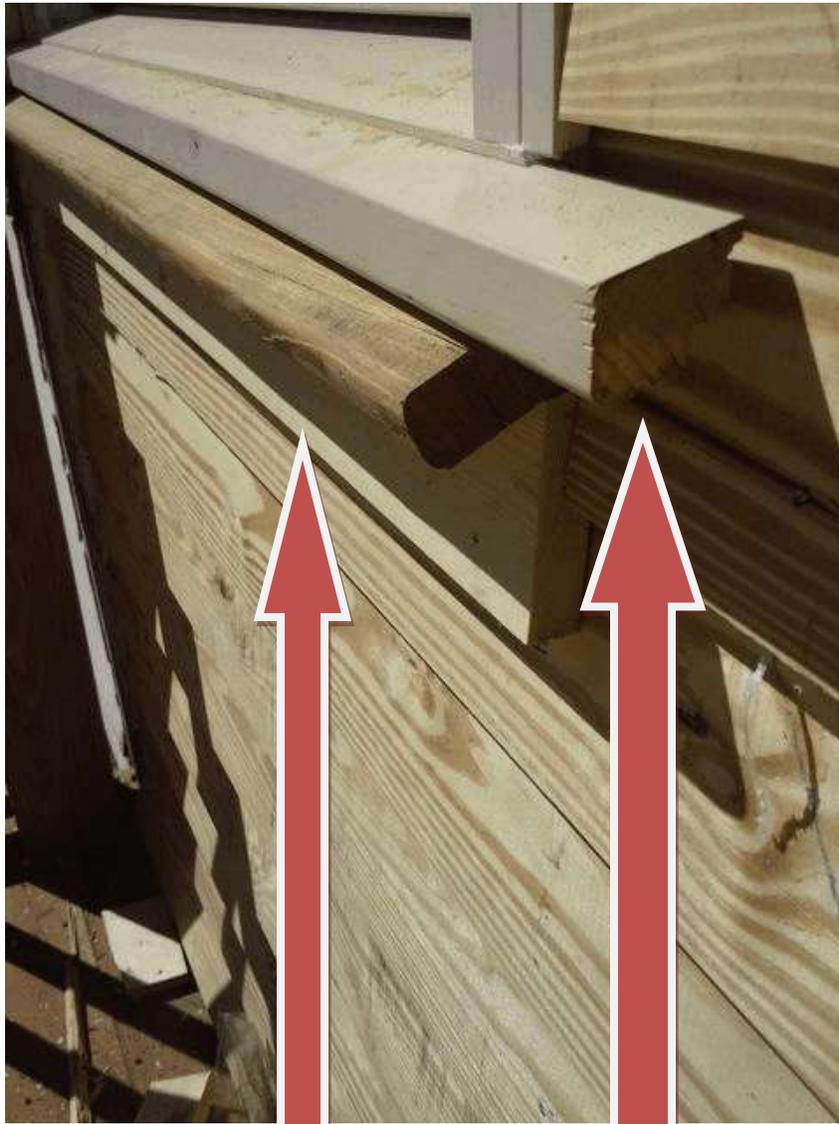
**Proposed subsill**

**Original sill**

**Exterior Sill Mockup – subsill added; angle adjusted to match slope  
of window sill**

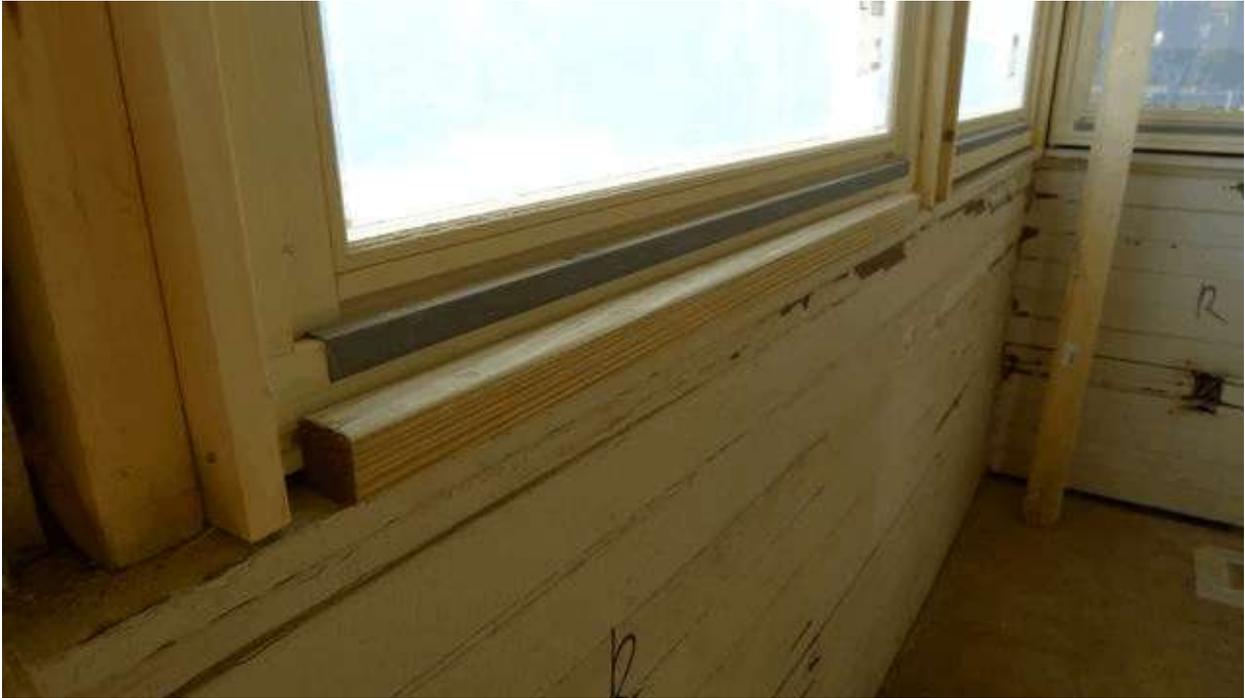
**Mockup of Interior Window Sill - 2 x 2 to be continuous ganged window openings**

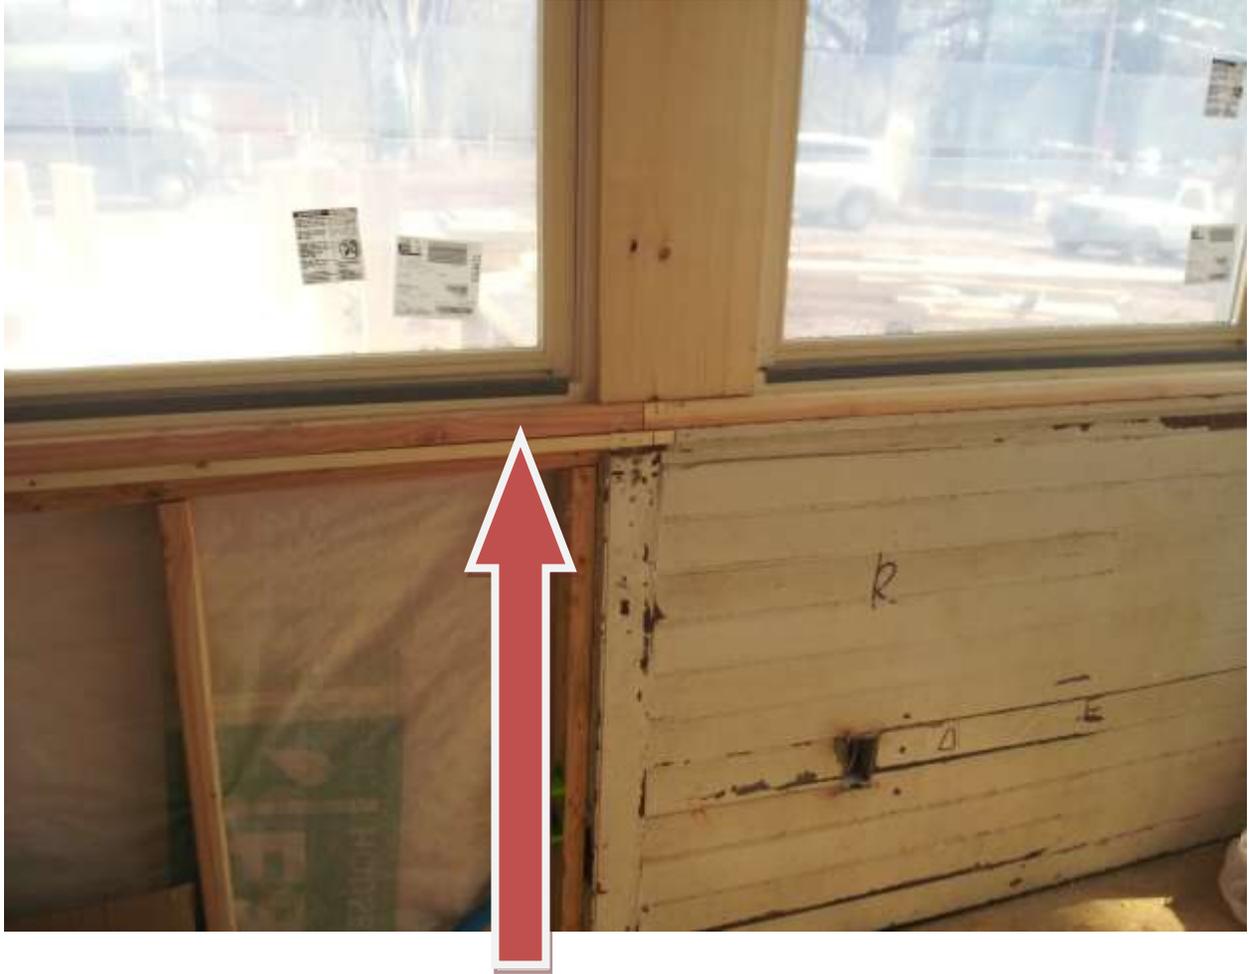
**Continuous interior window sill installed (2"x 2")**

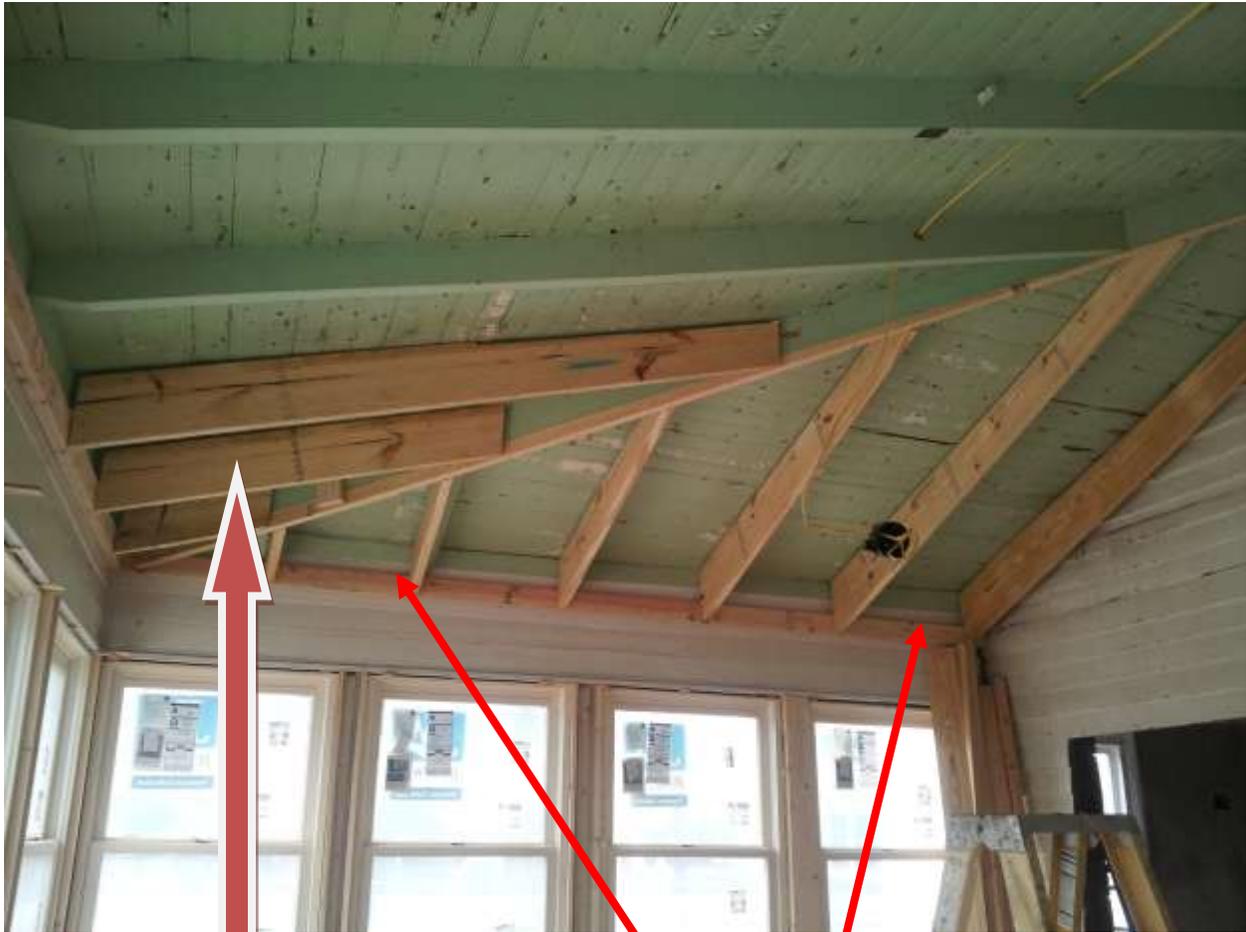
**New Framing**

**Different slopes**

**See modification (completed as of 2/15) to underside of existing roof framing in reception/waiting room area – existing framing a combination of 2 x4's and 2 x 6's of various slopes – flat gypsum board cannot be applied to different board depths – various alternatives considered from a drop ceiling to furr stripping**

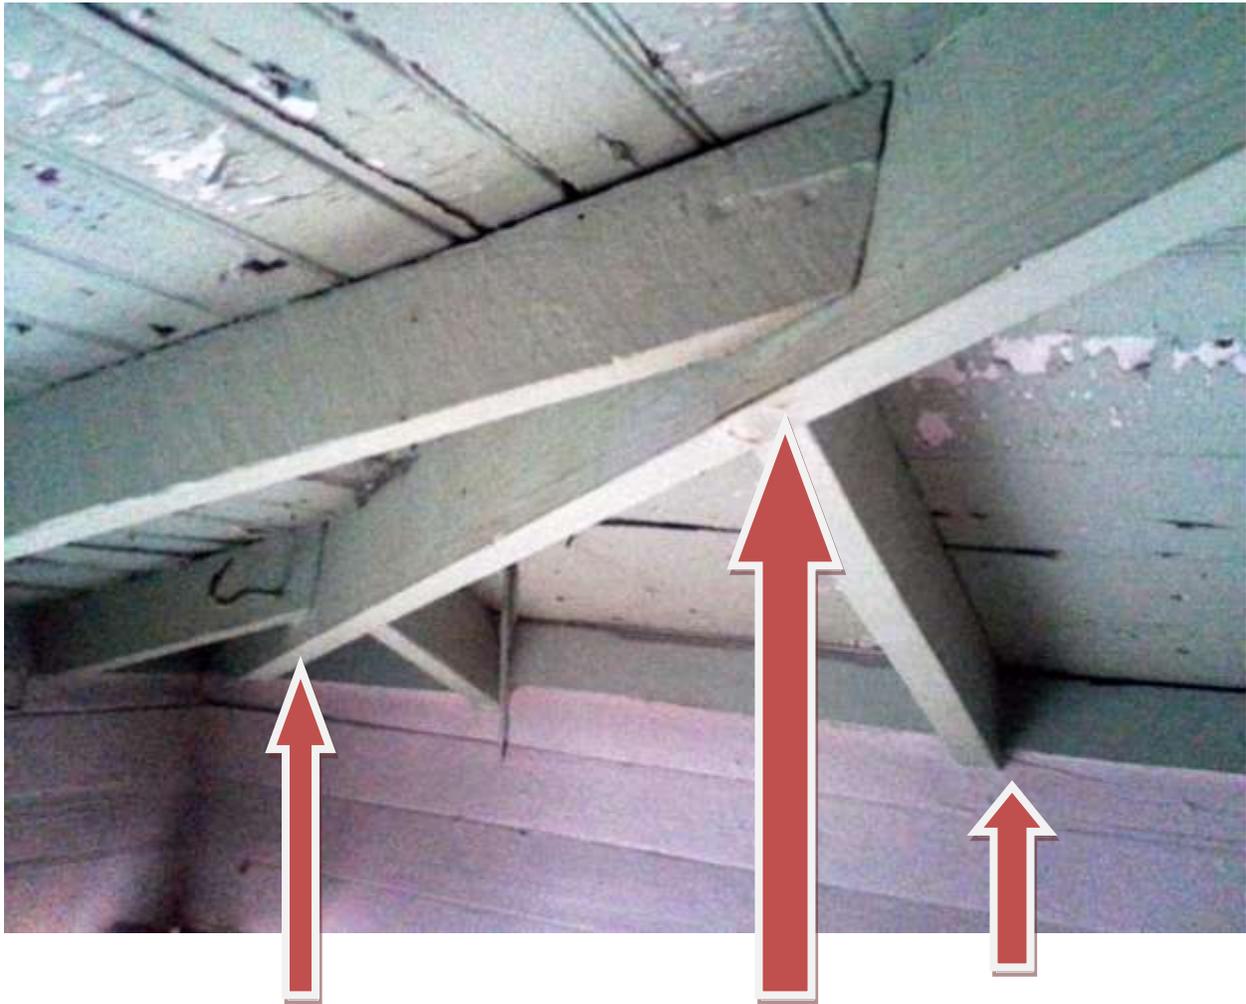
**See different board depths of existing framing underside of roof in reception/waiting room**

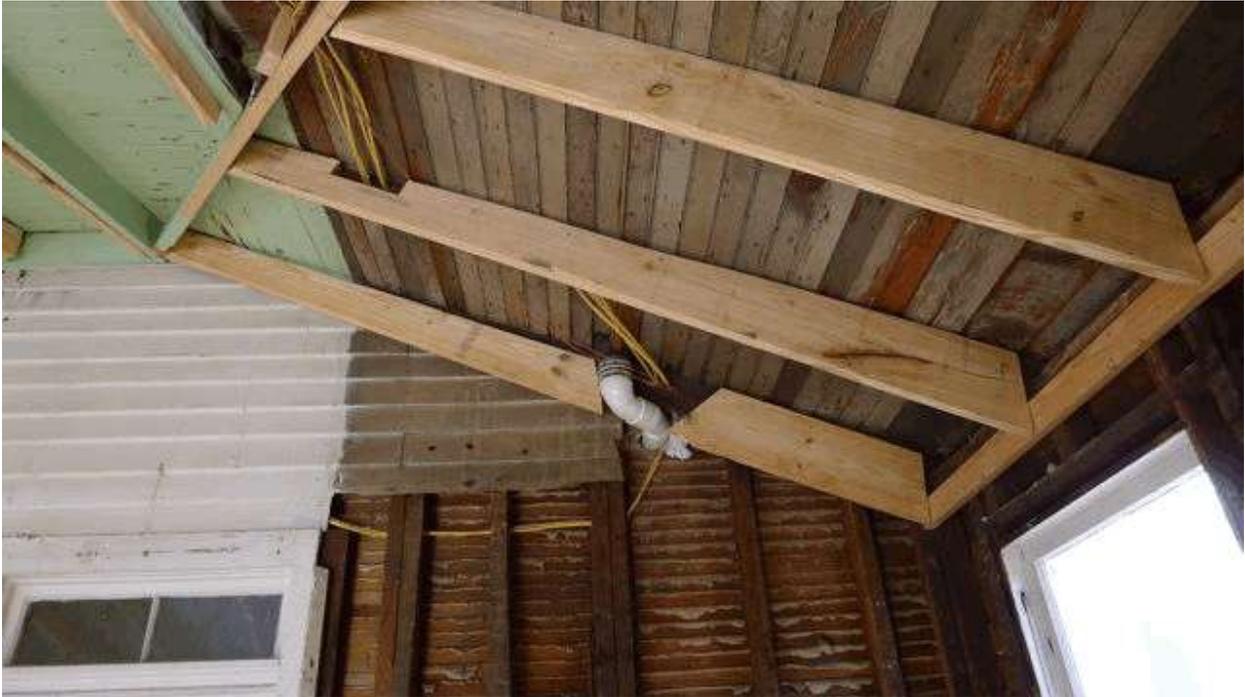
**Additional ceiling framing sistered to existing framing – waiting area**

(out of scope – contractor did not request a change order)

**See plumbing vent – change order prepared for building a false wall/shelving to cover exposed vent – additional framing solved this problem**

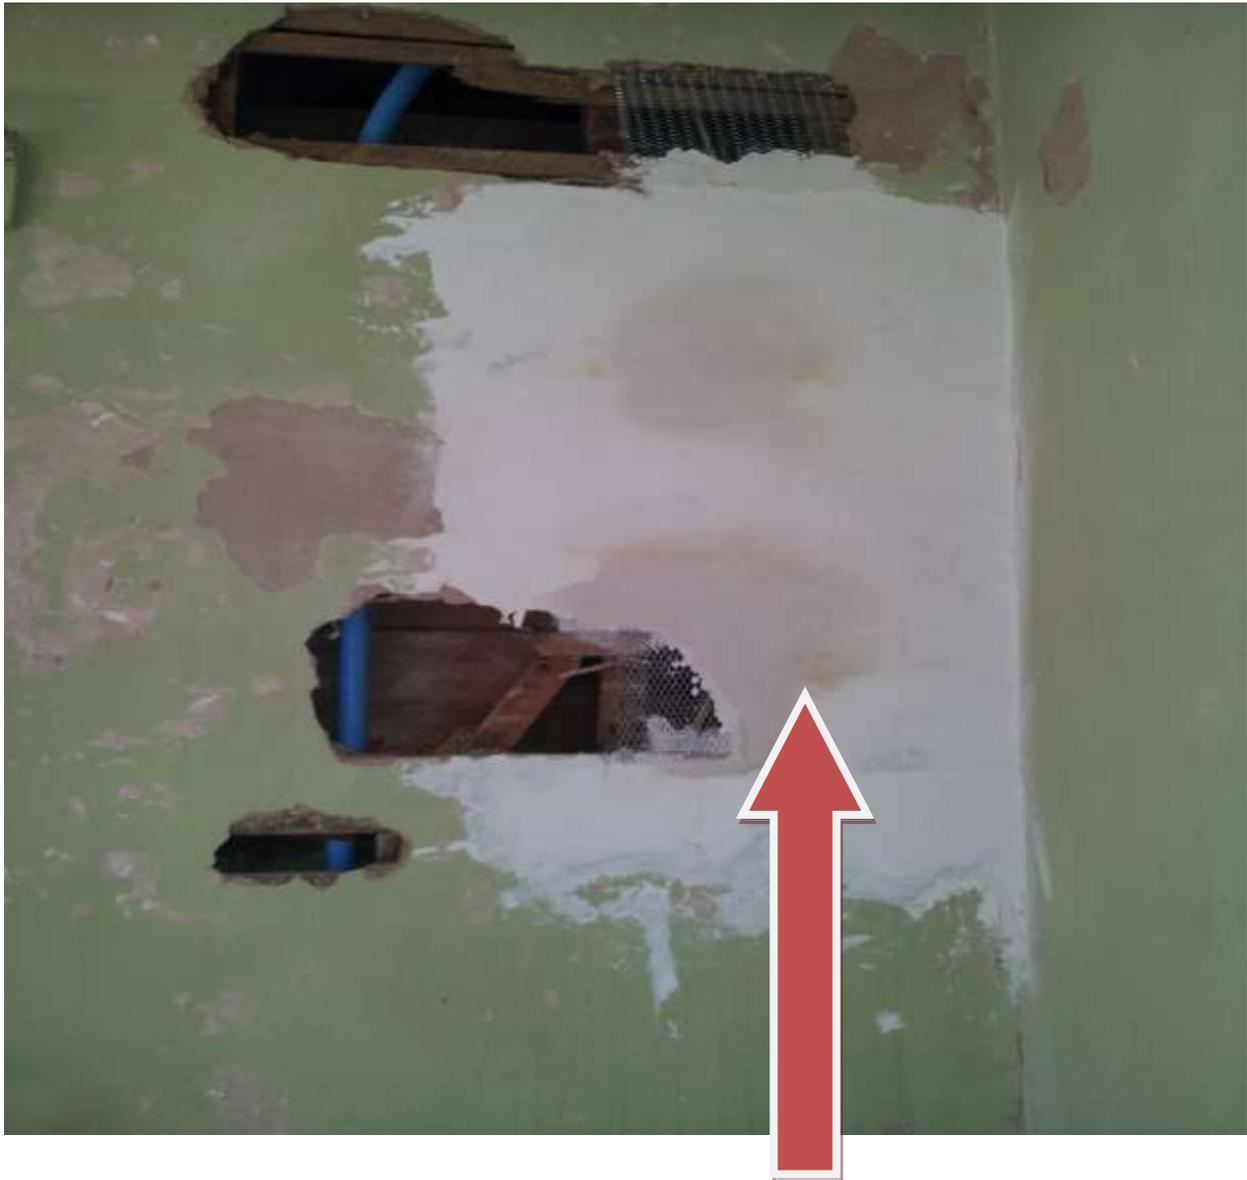
### **Plaster mock up**

(See light & dark areas – moisture from differing temperatures – HVAC turned on – house temperature will stabilize and dark color will disappear)

- ✓ Plans call for patching plaster walls (25% of the wall area). Currently assessing potential alternatives if patching proves to be unsuccessful in the mockup
- ✓ Excavation in parking lot area encountered unsuitable soils – negotiate with Macallan Group costs and responsibilities to remove and stabilize subgrade before stone base course is placed and paving occurs

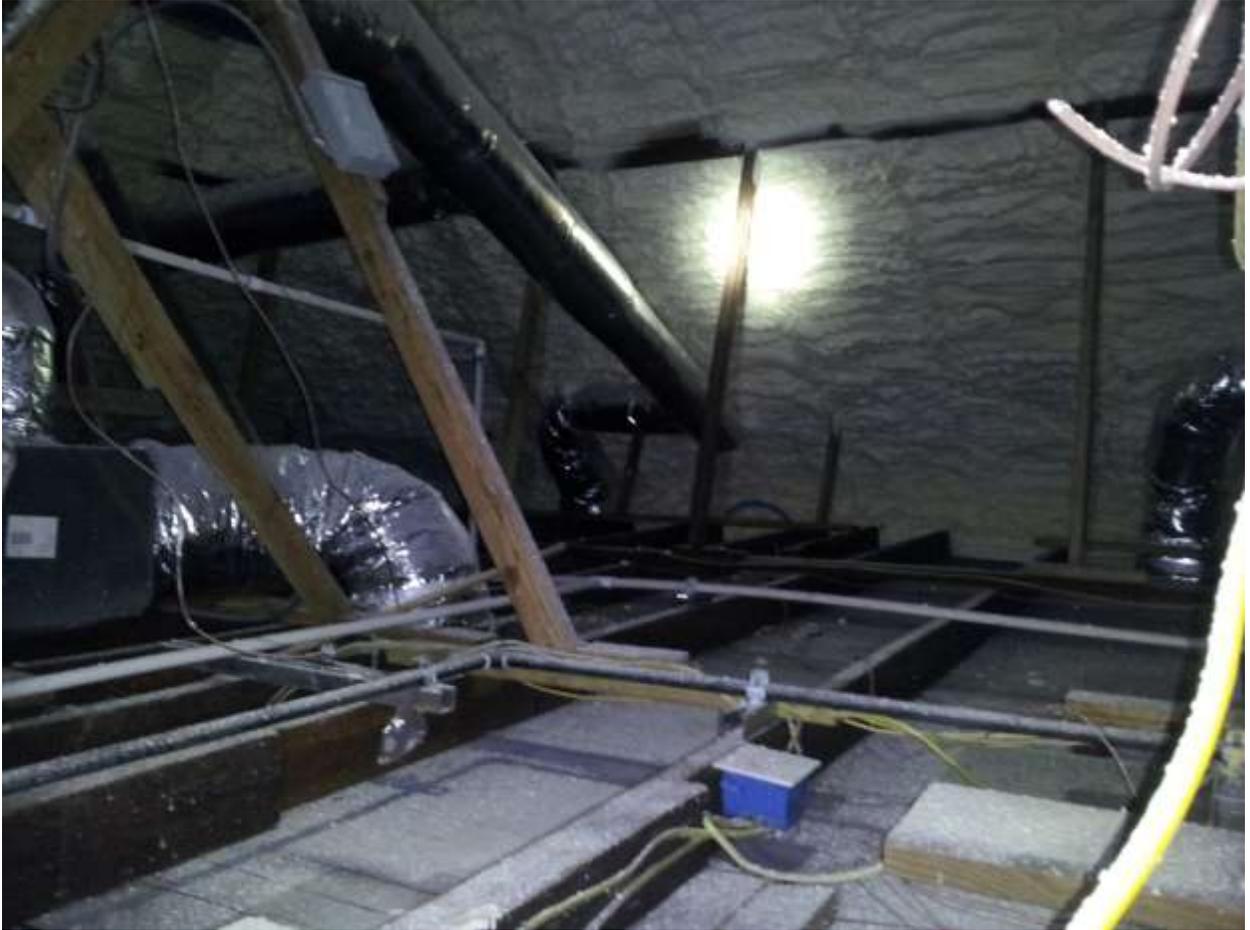
**Open Cell Spray Foam Insulation Applied in Attic – all ceiling surfaces**

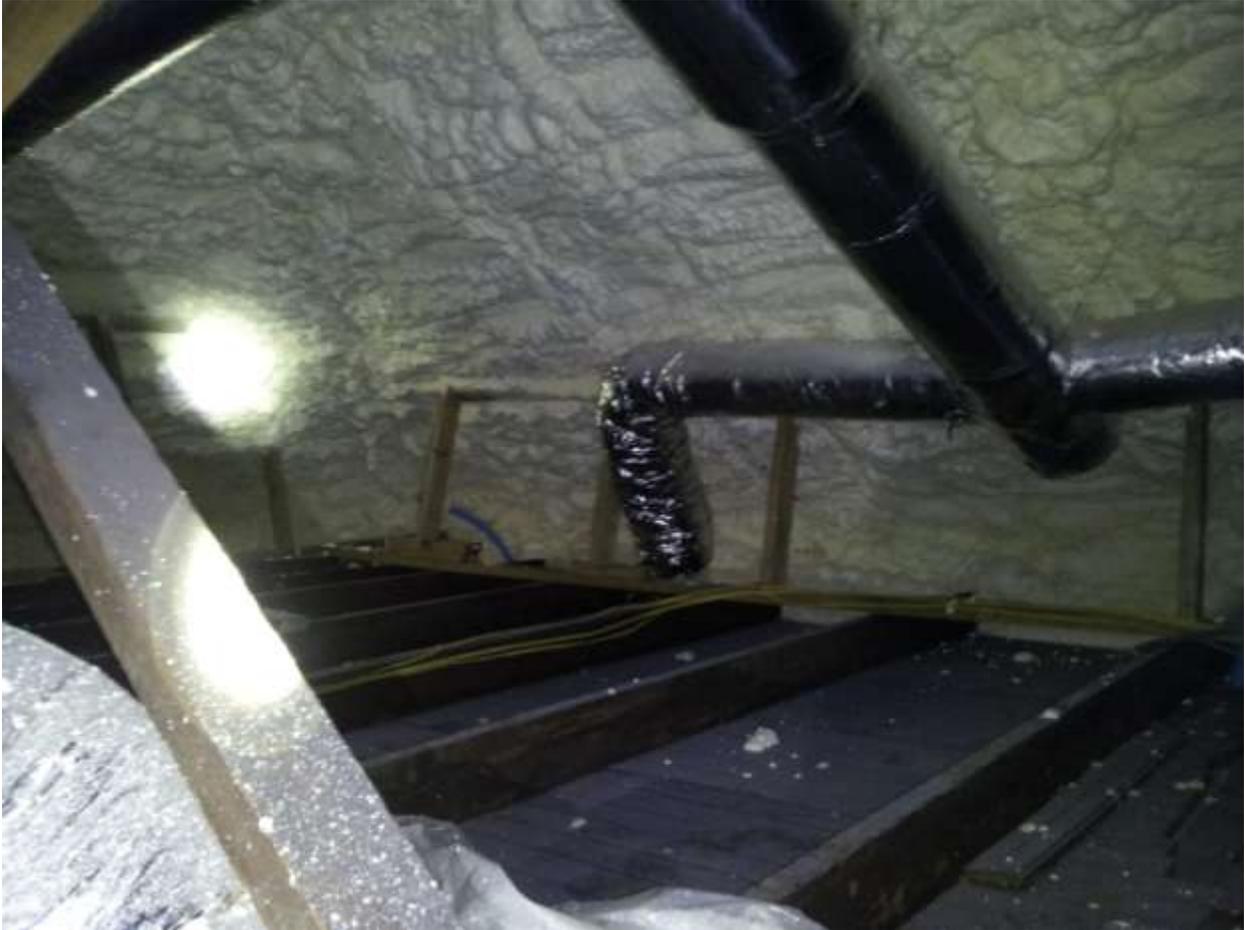
**Open Cell Spray Foam Insulation in attic**

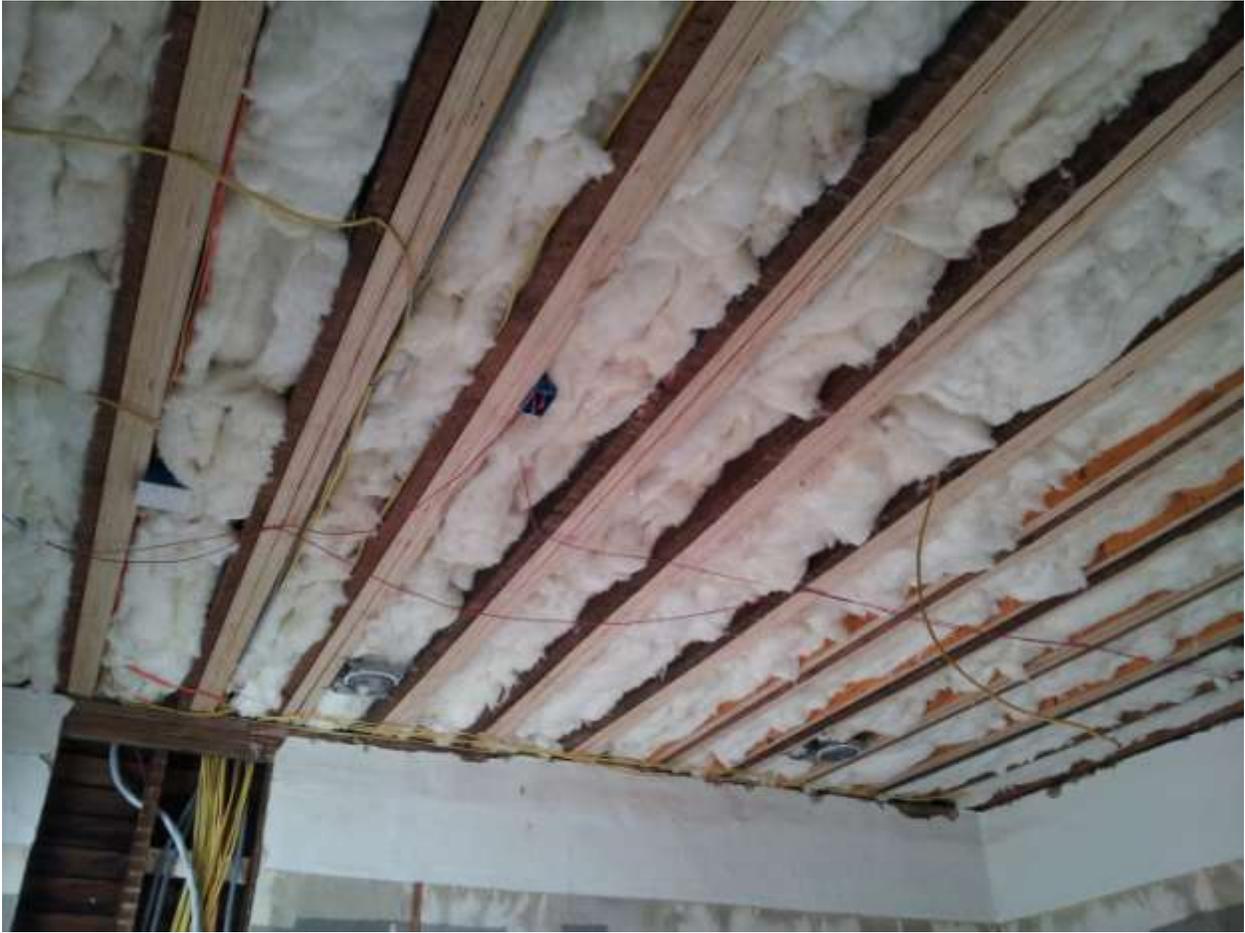
**Sound attenuation batt insulation in 1<sup>st</sup> floor ceiling joists – “sound break”  
gypsum to be installed (change order #2 approved by council 12/18)**

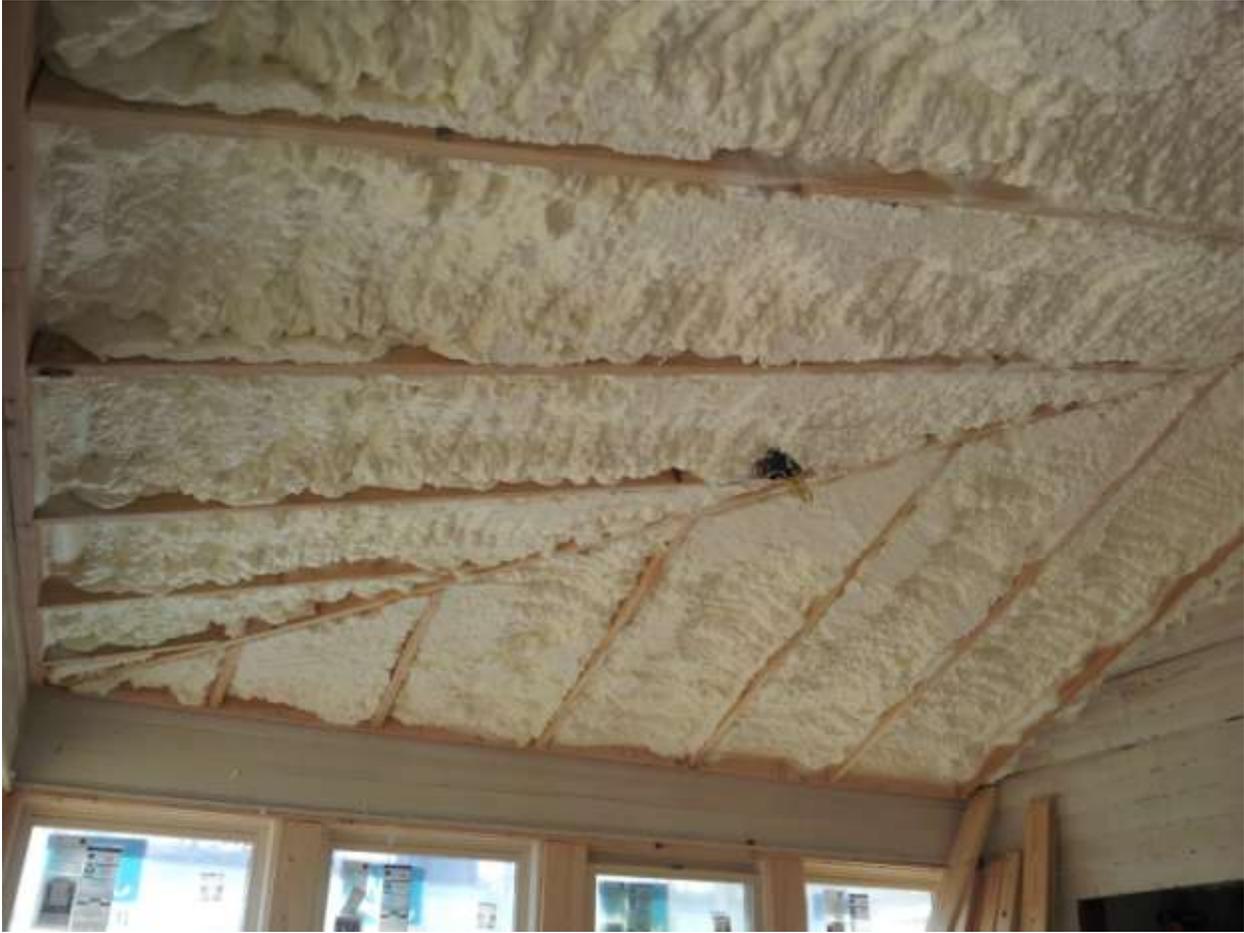
**Open Cell Spray Foam Insulation Reception/Waiting Room**
